Radiography incident in Belgium

- Recovery of a Co-60 source in a foundry

Rutger Berden

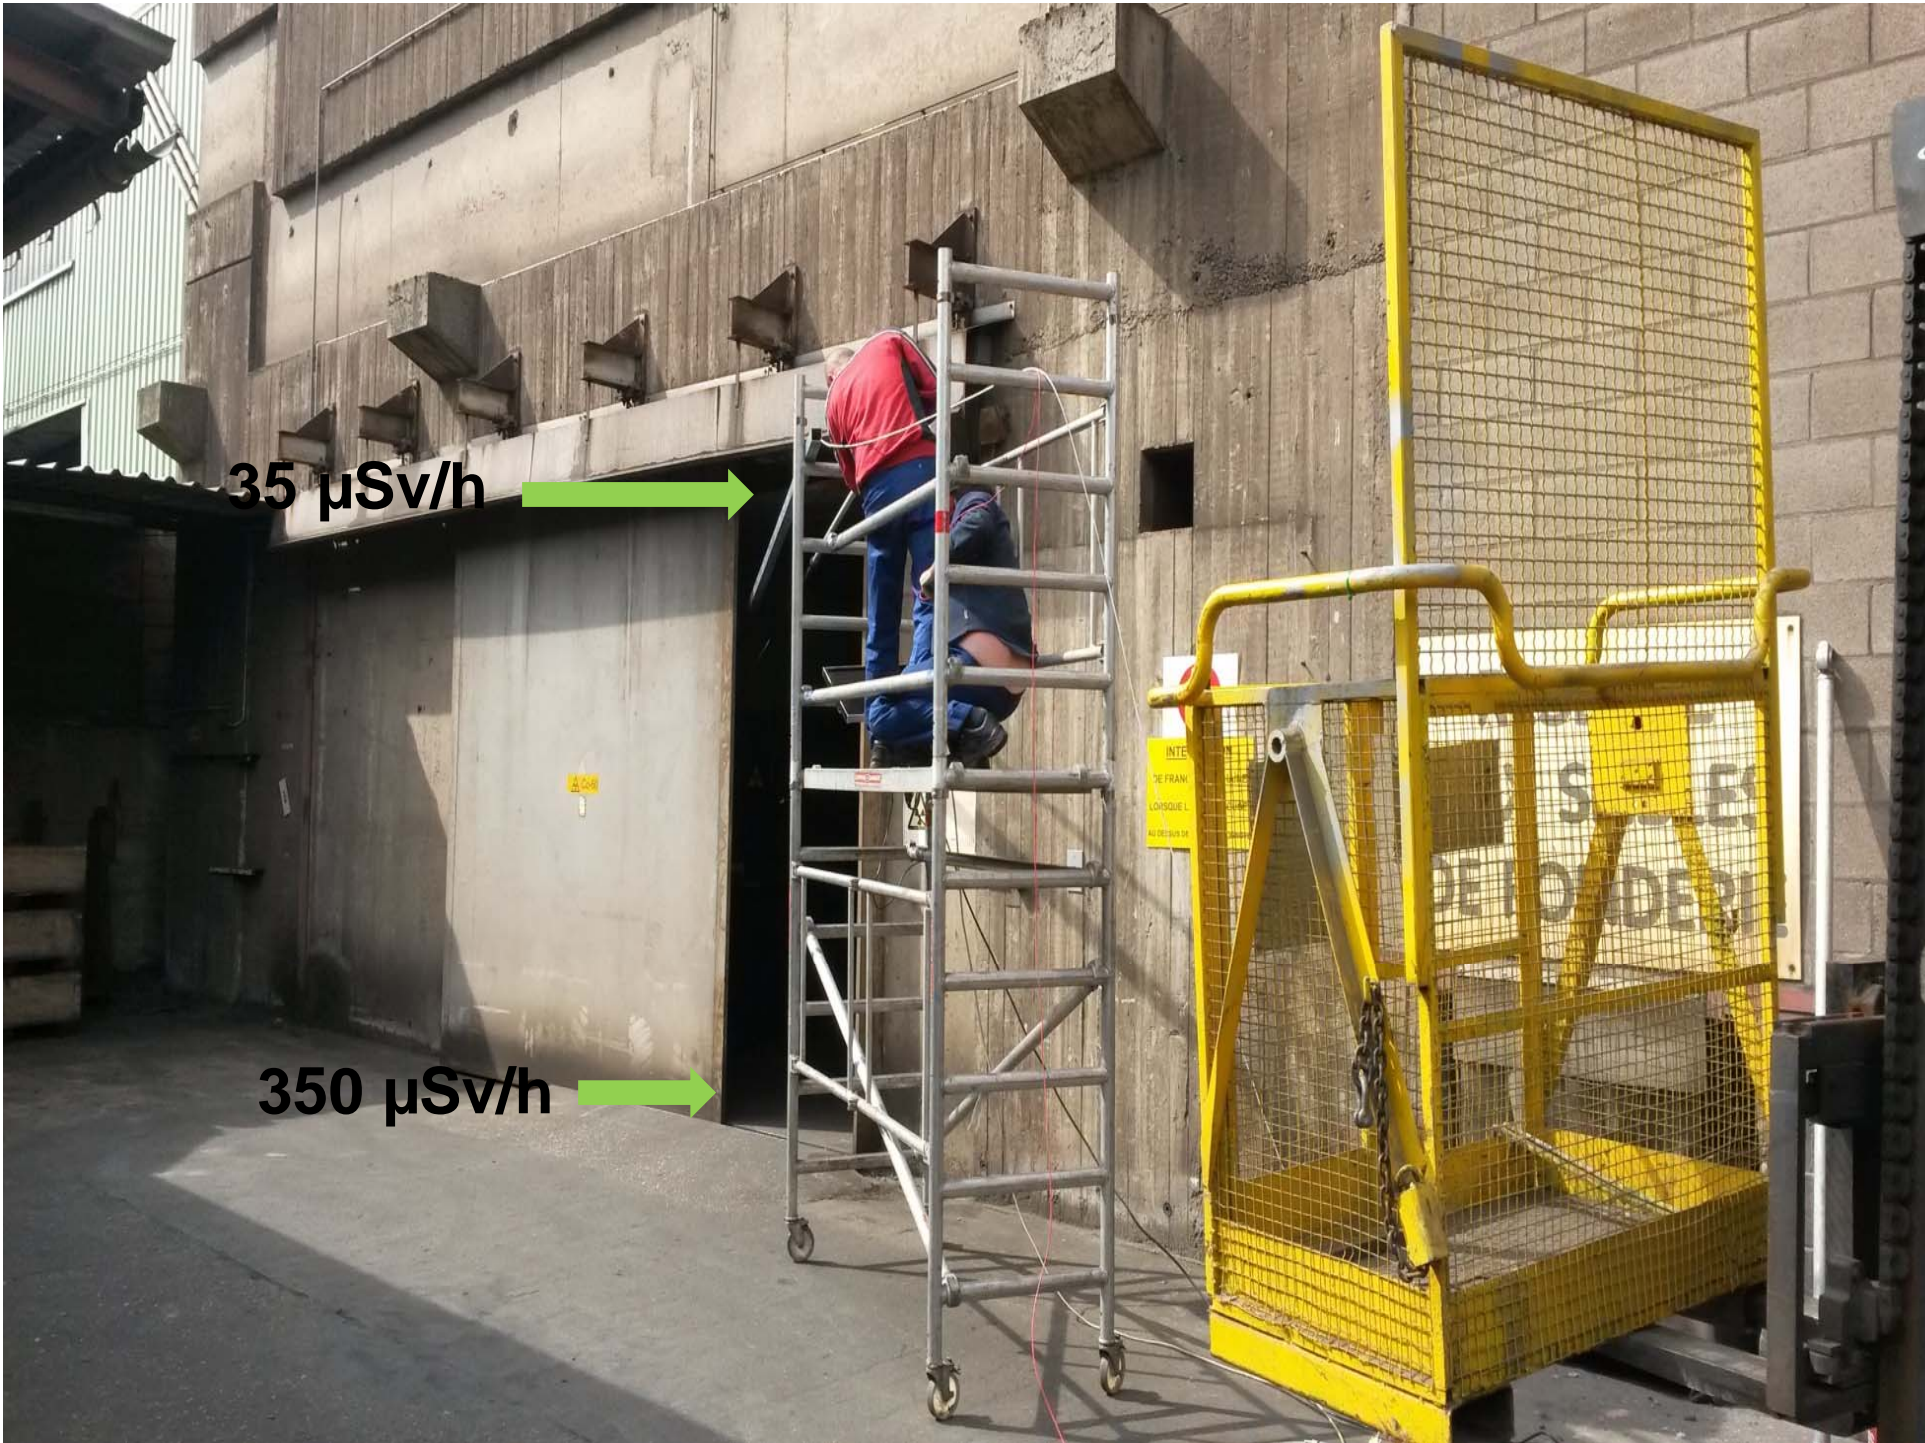
Friday 10 April 2015

- ✓ 10h30: source blocked outside the container
- ✓ No exposure of operators or public
 - ➔ security devices worked properly

First intervention to retrieve the source under supervision of certified organism and with the help of manufacturer with a camera and a long pole with a gripper.

- ➔ Ejection sheet unblocked, but source remained outside container.
- ✓ 15h22: Notification FANC

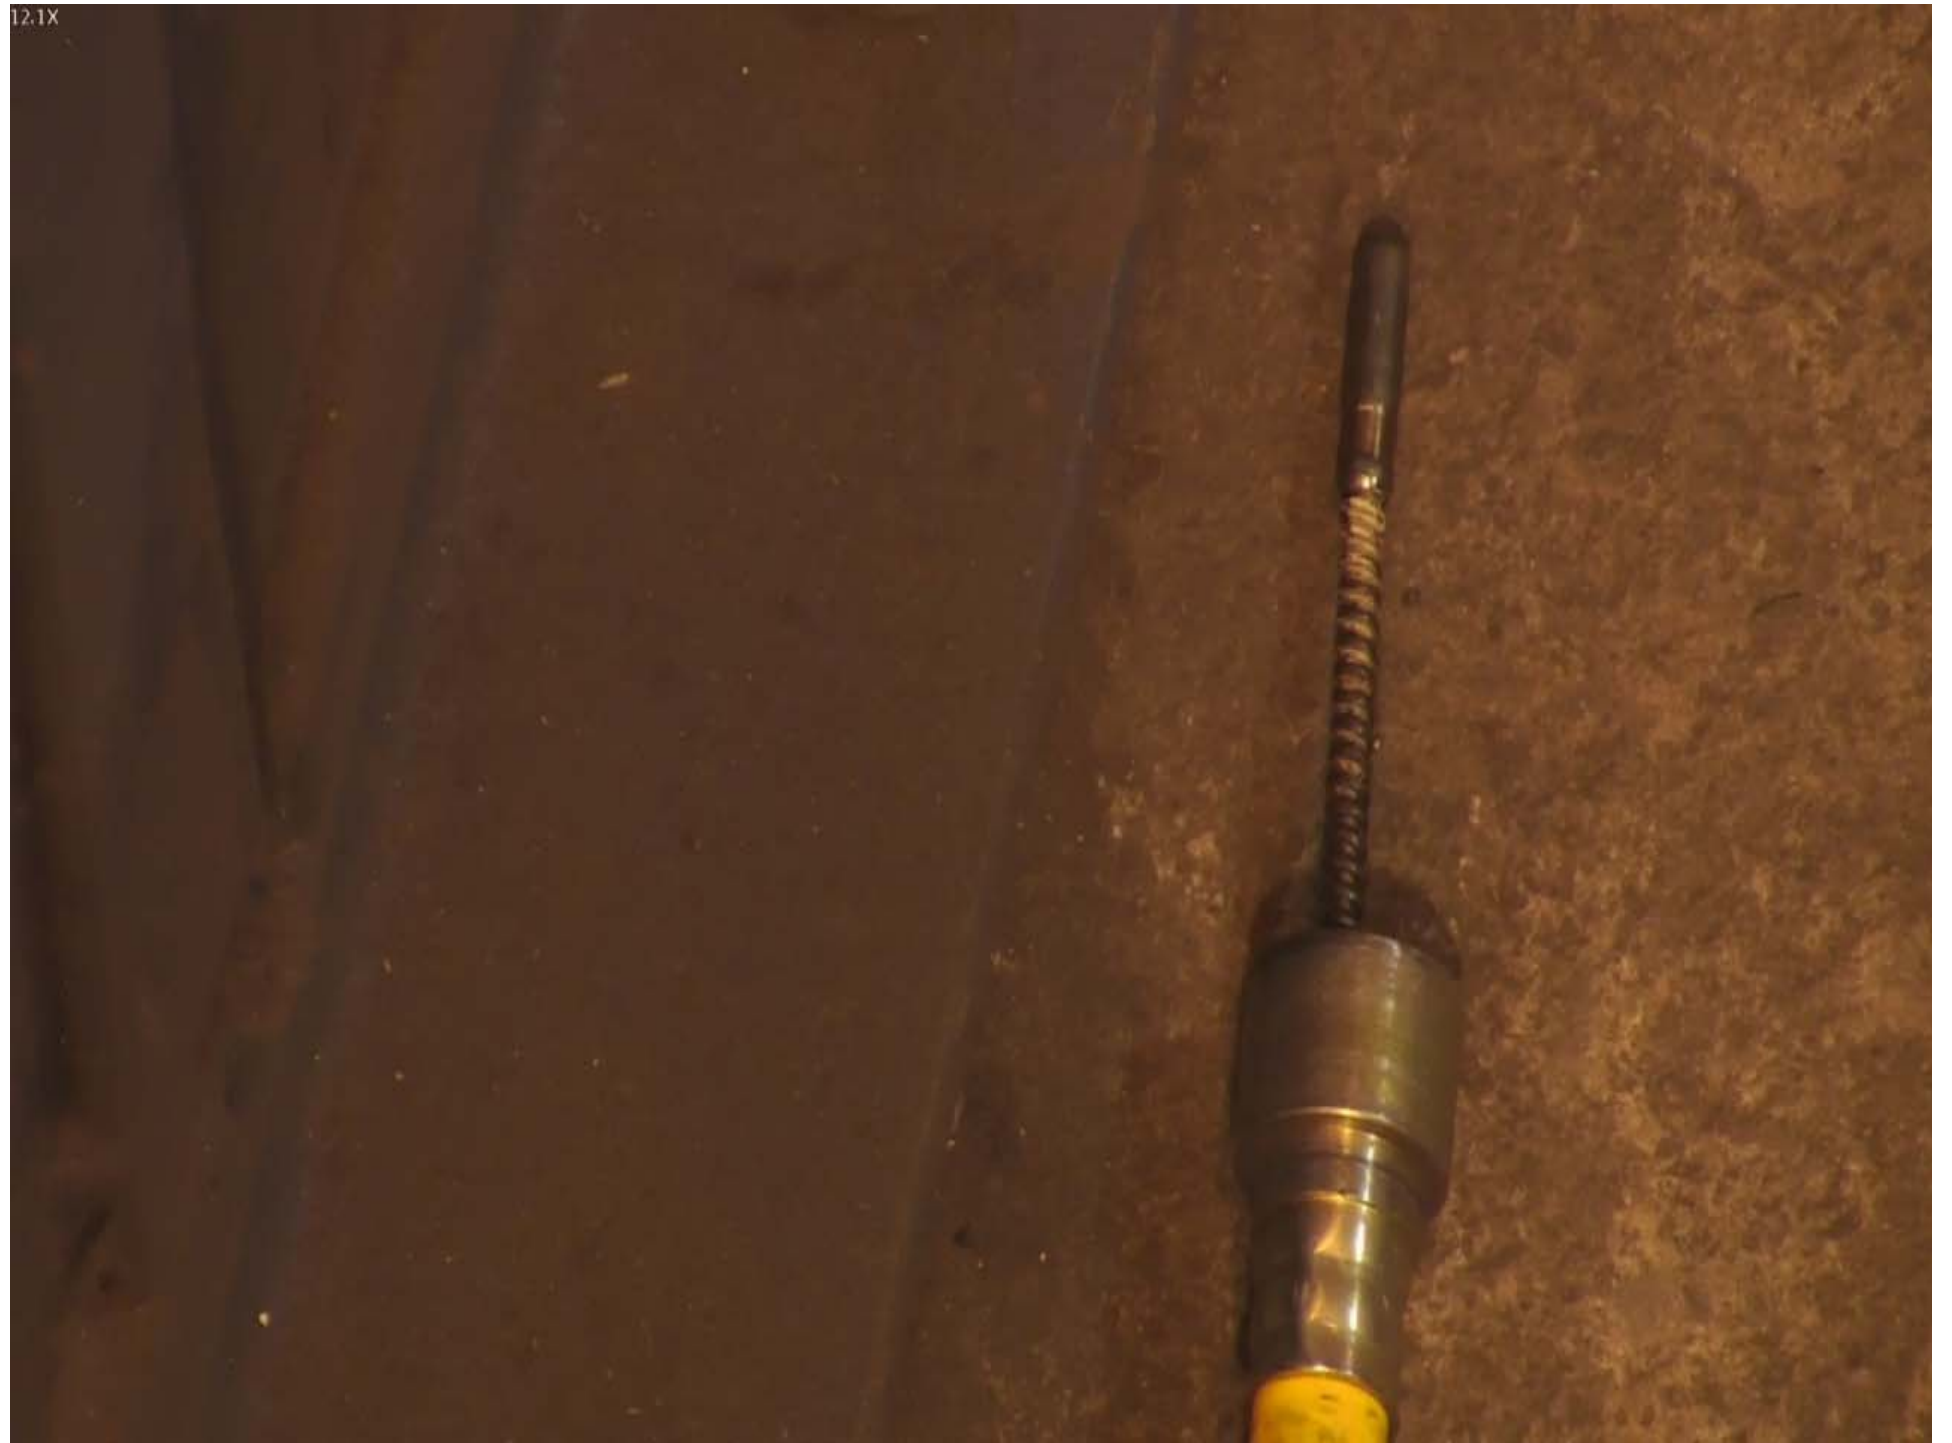
Monday 13 April 2015

Second intervention: similar to first but with new dome camera for better view.

- ➔ Cable unblocked and partially returned but source remained outside container.
- ➔ Further interventions not allowed by inspection organisation and FANC

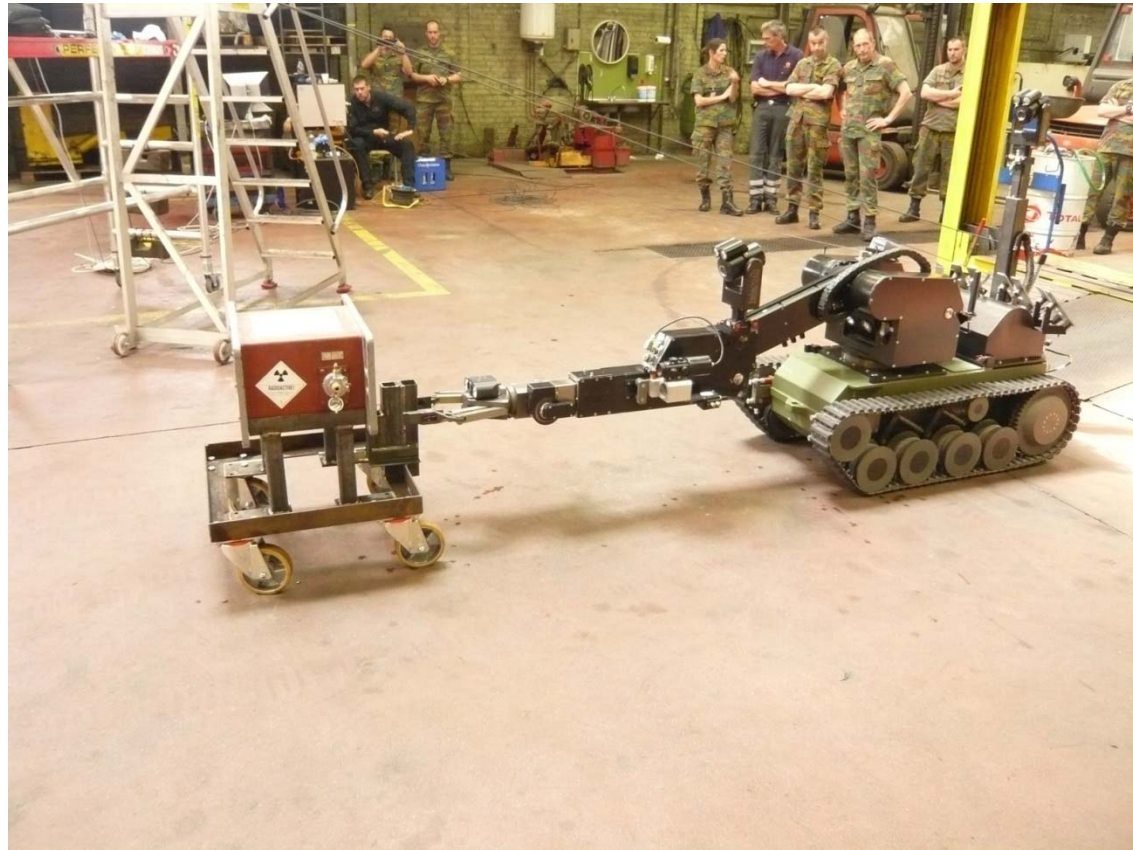
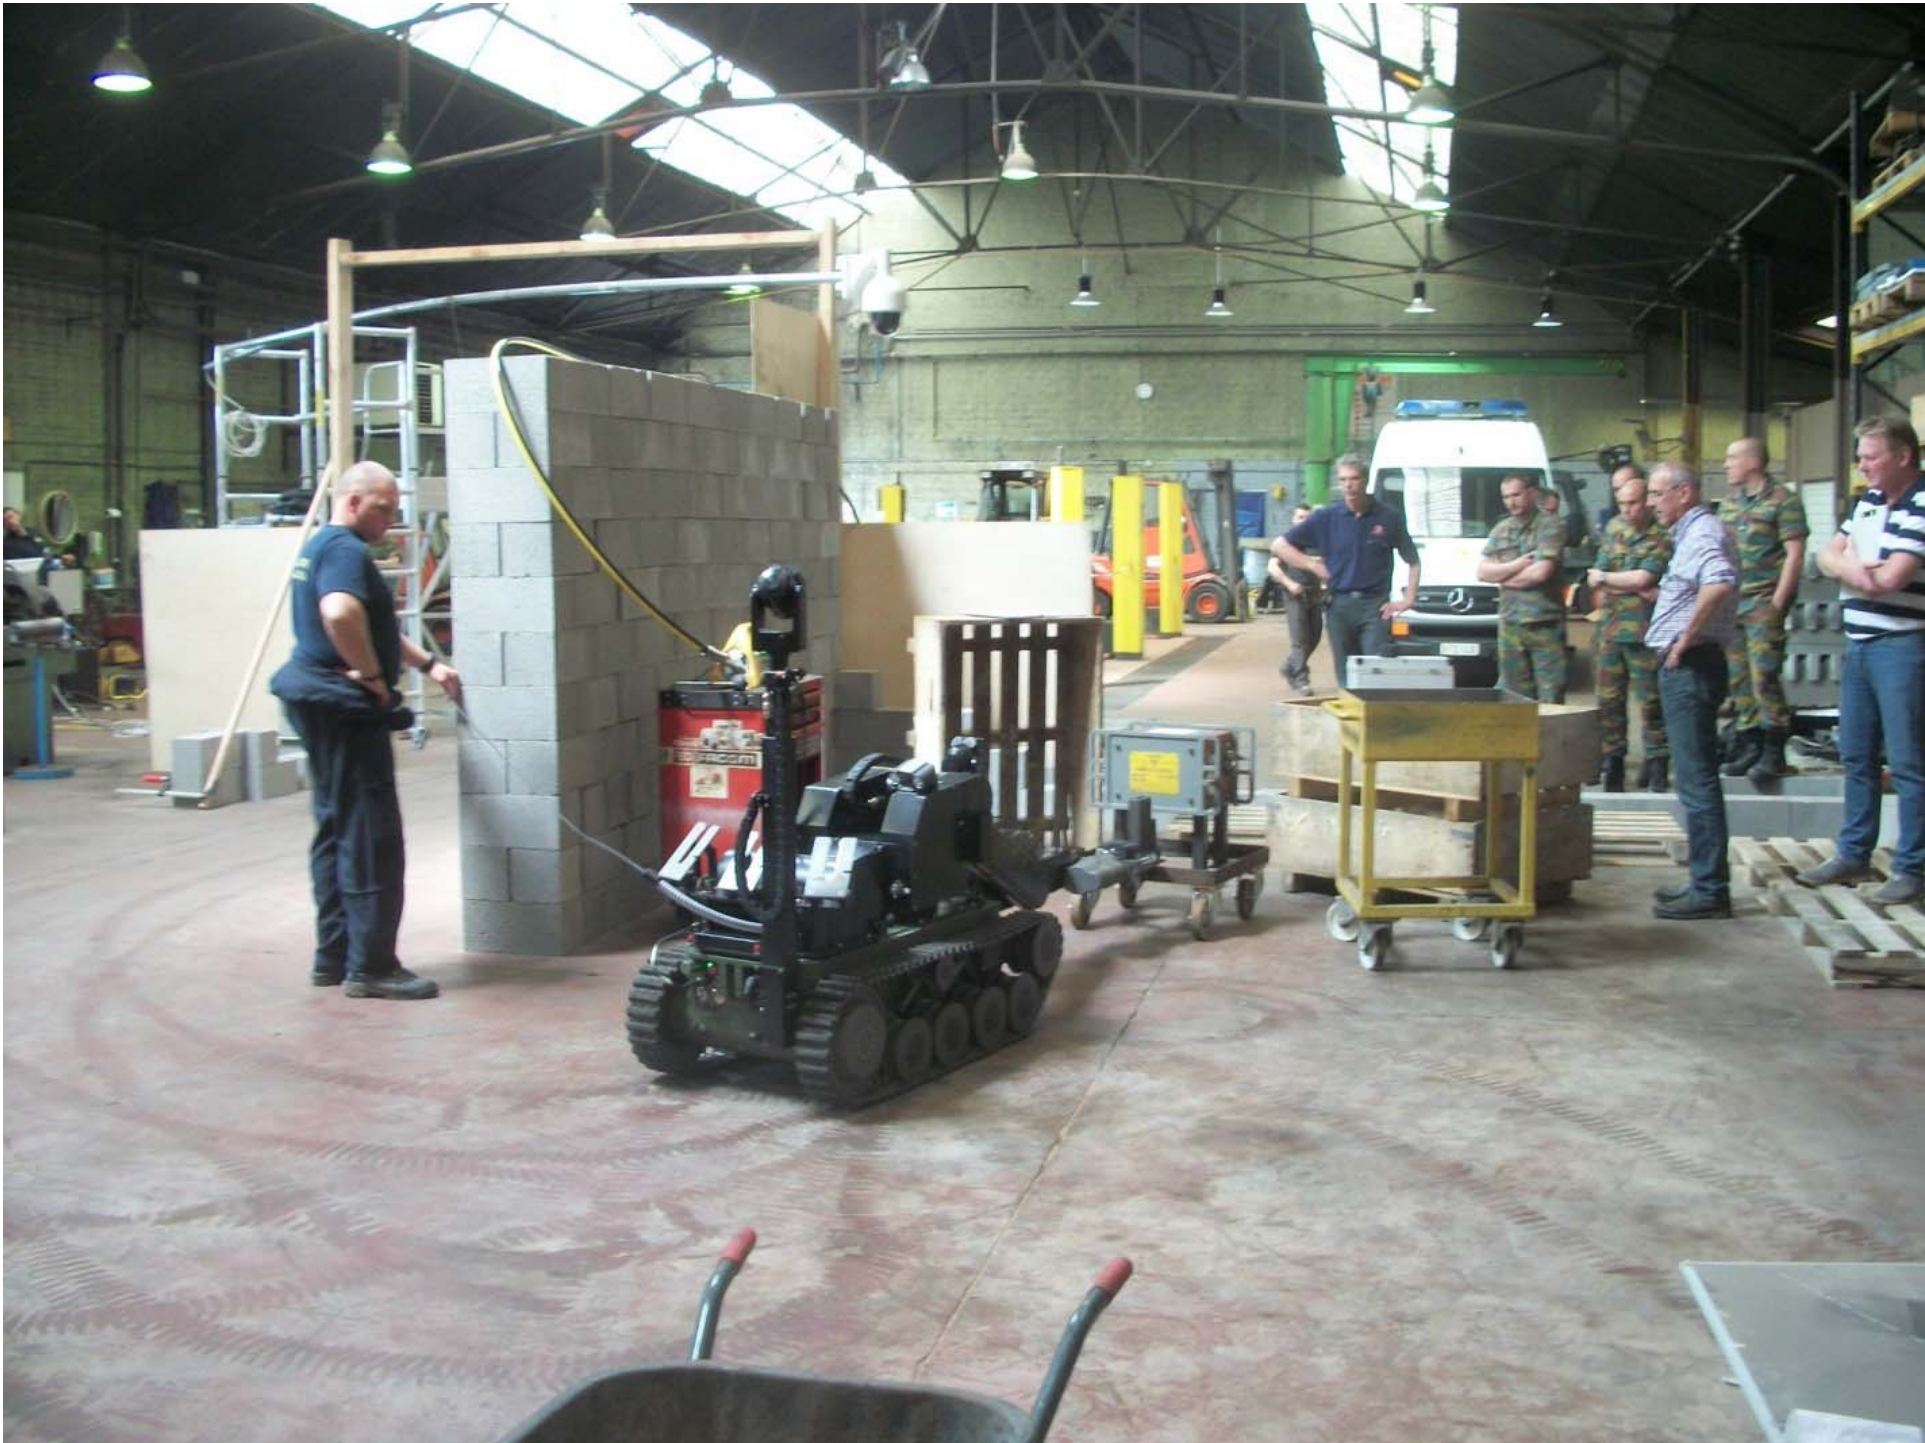
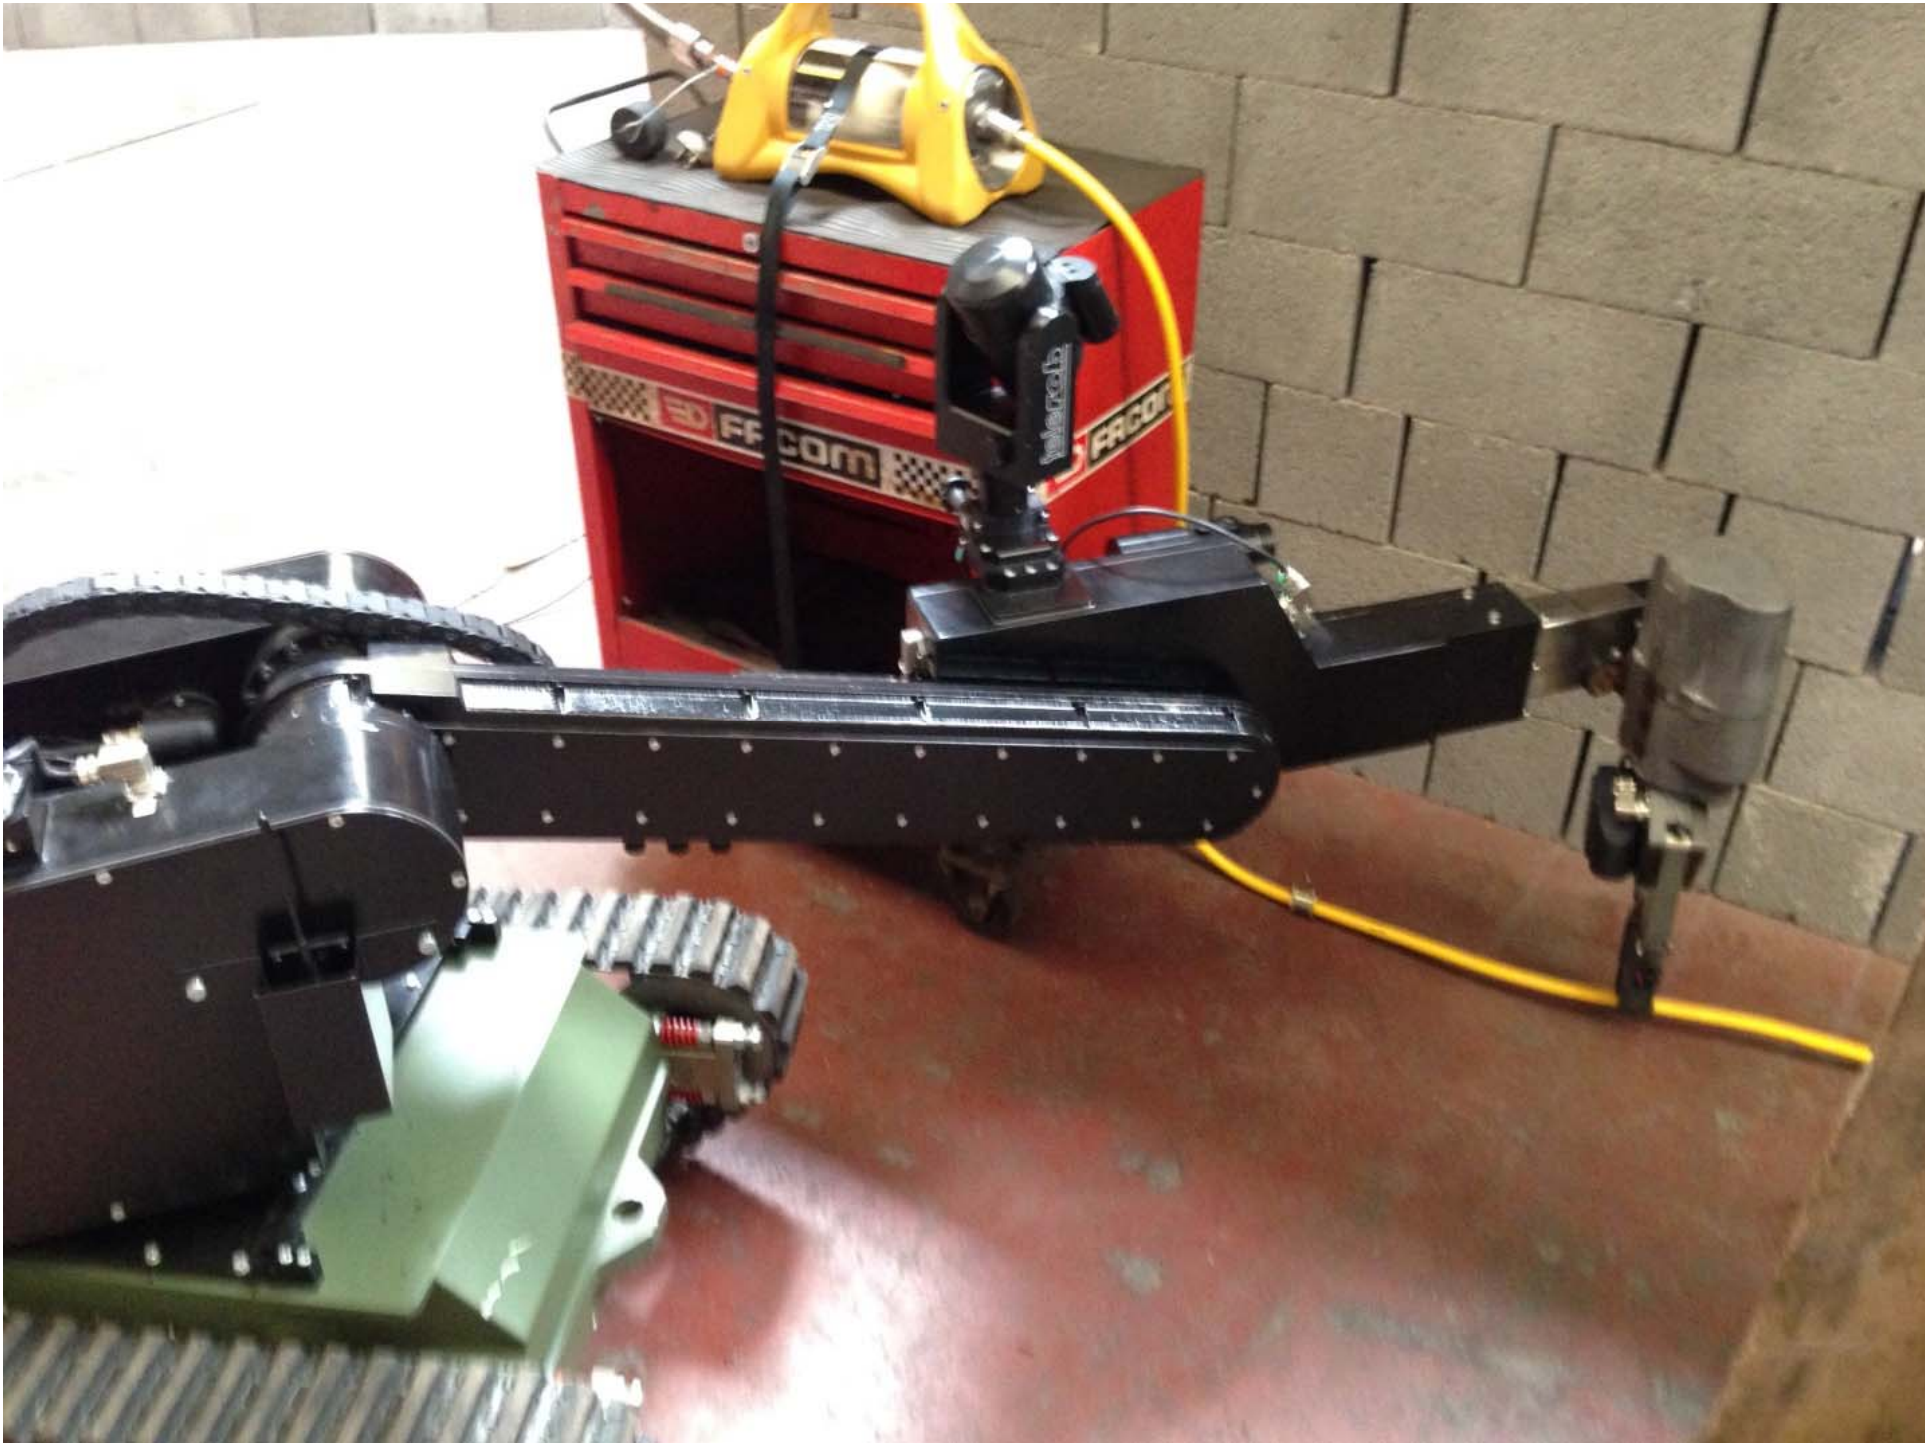
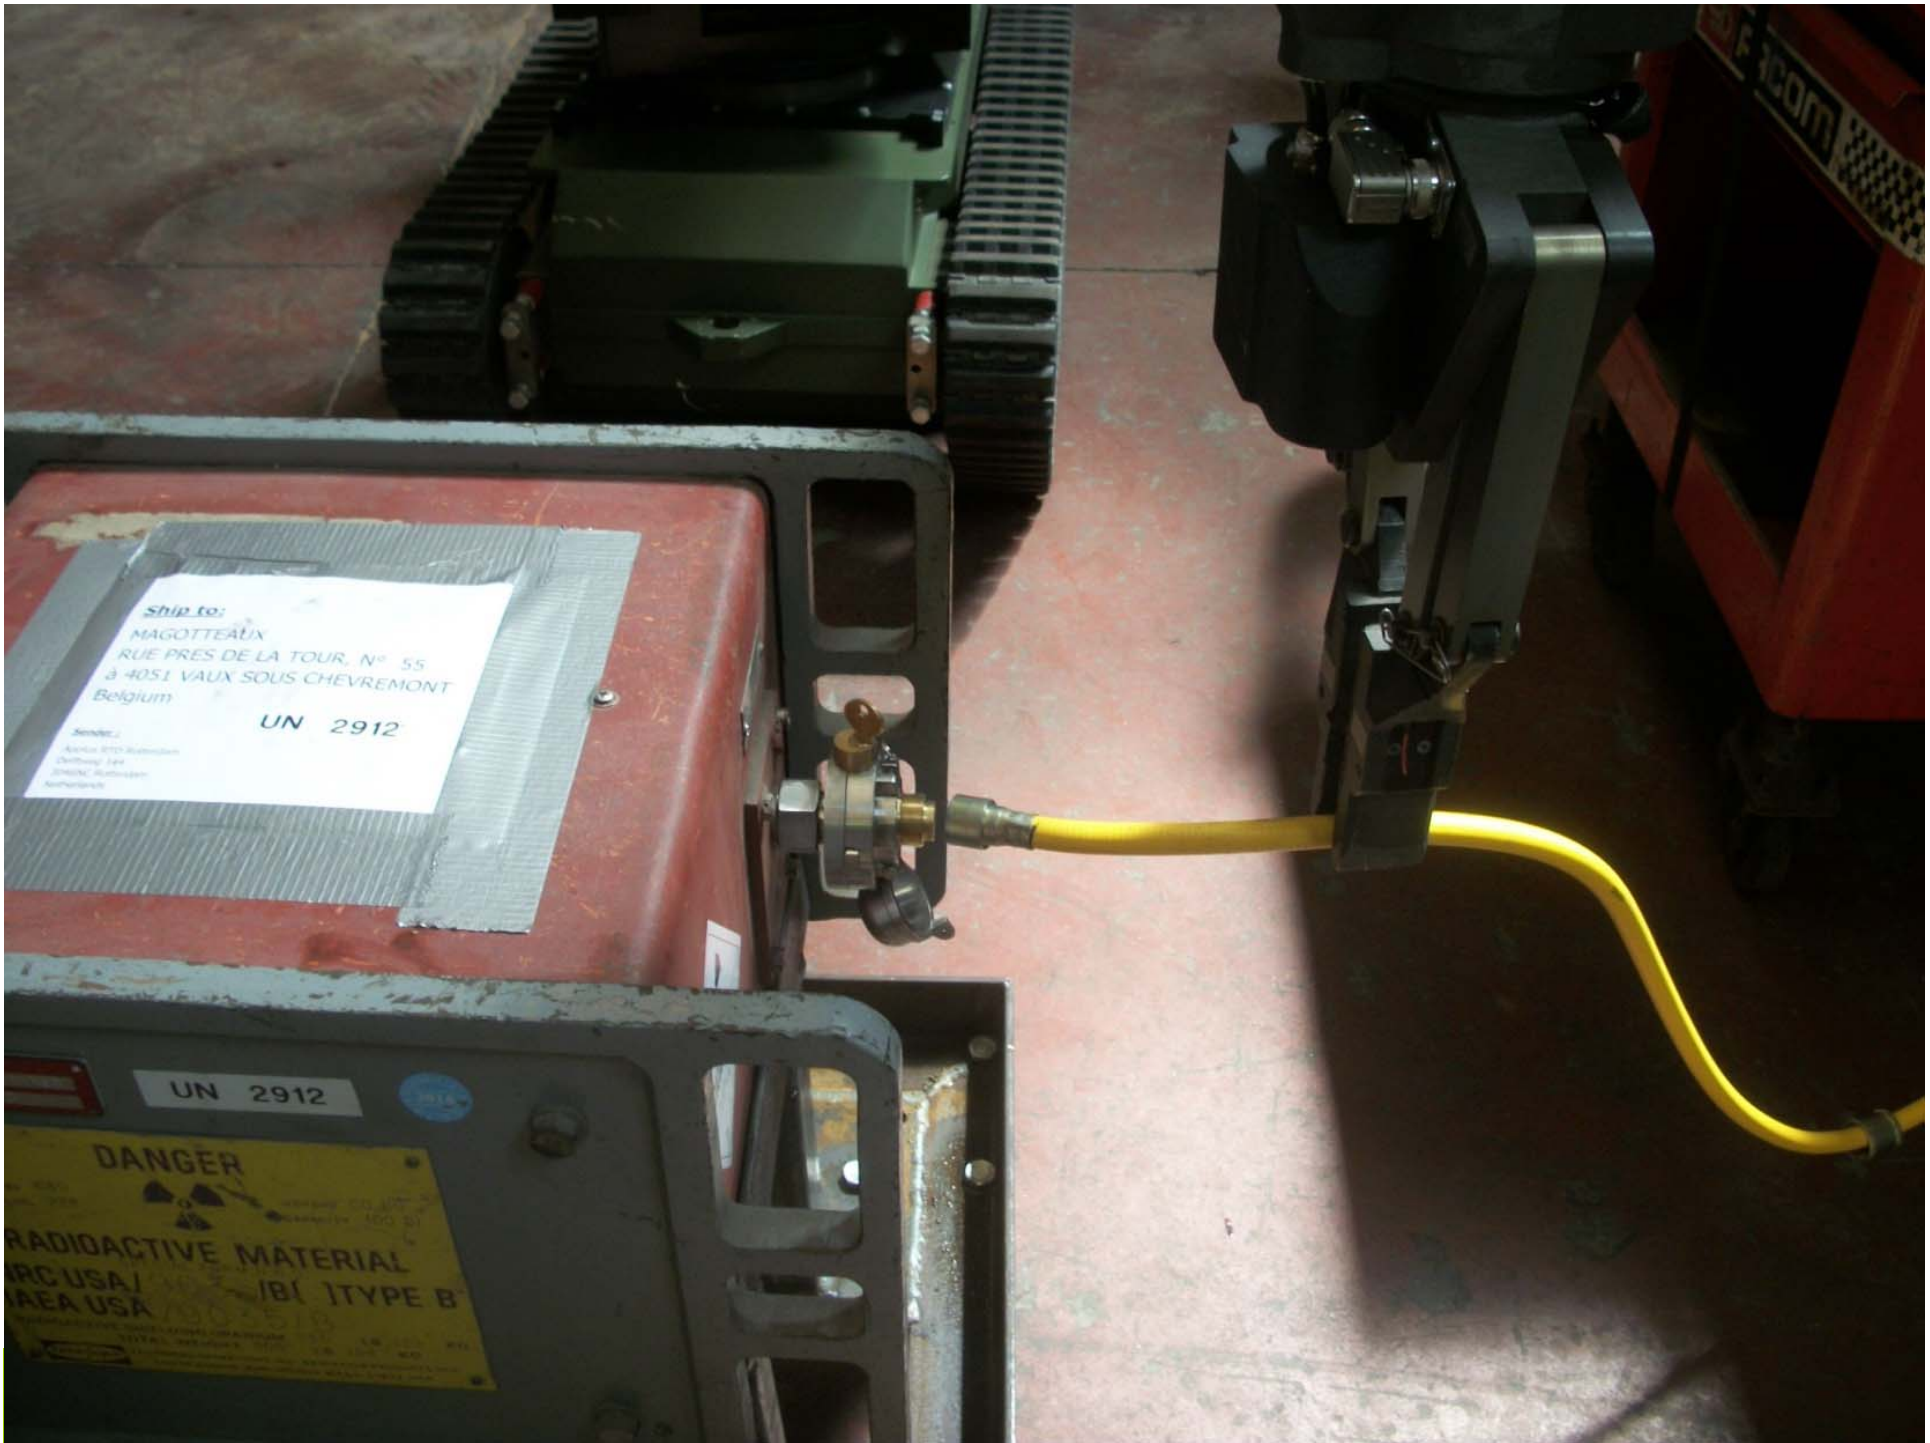
Robot moving the container that will house the source

Undercarriage fabricated for source retrieval

Tests showed that undercarriage needed to be modified

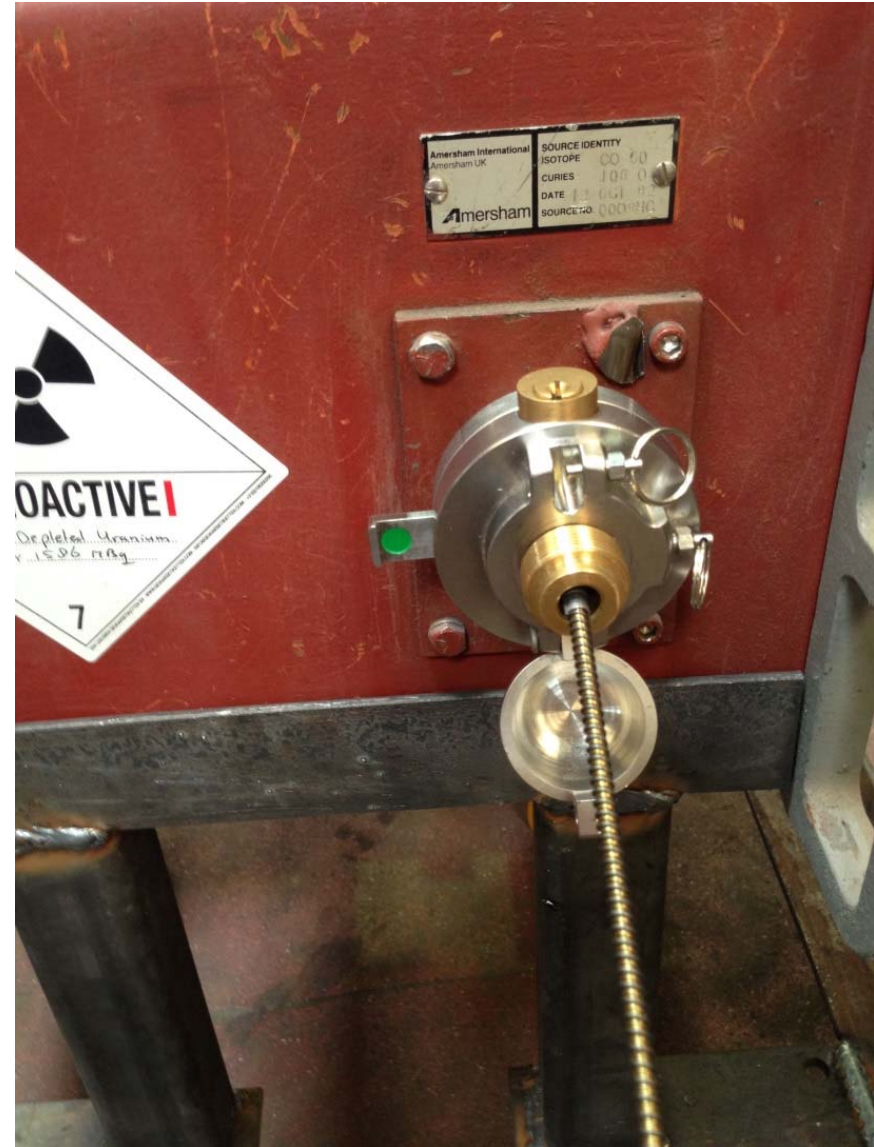
Test source entered in
container

safely interlocked

success of the test

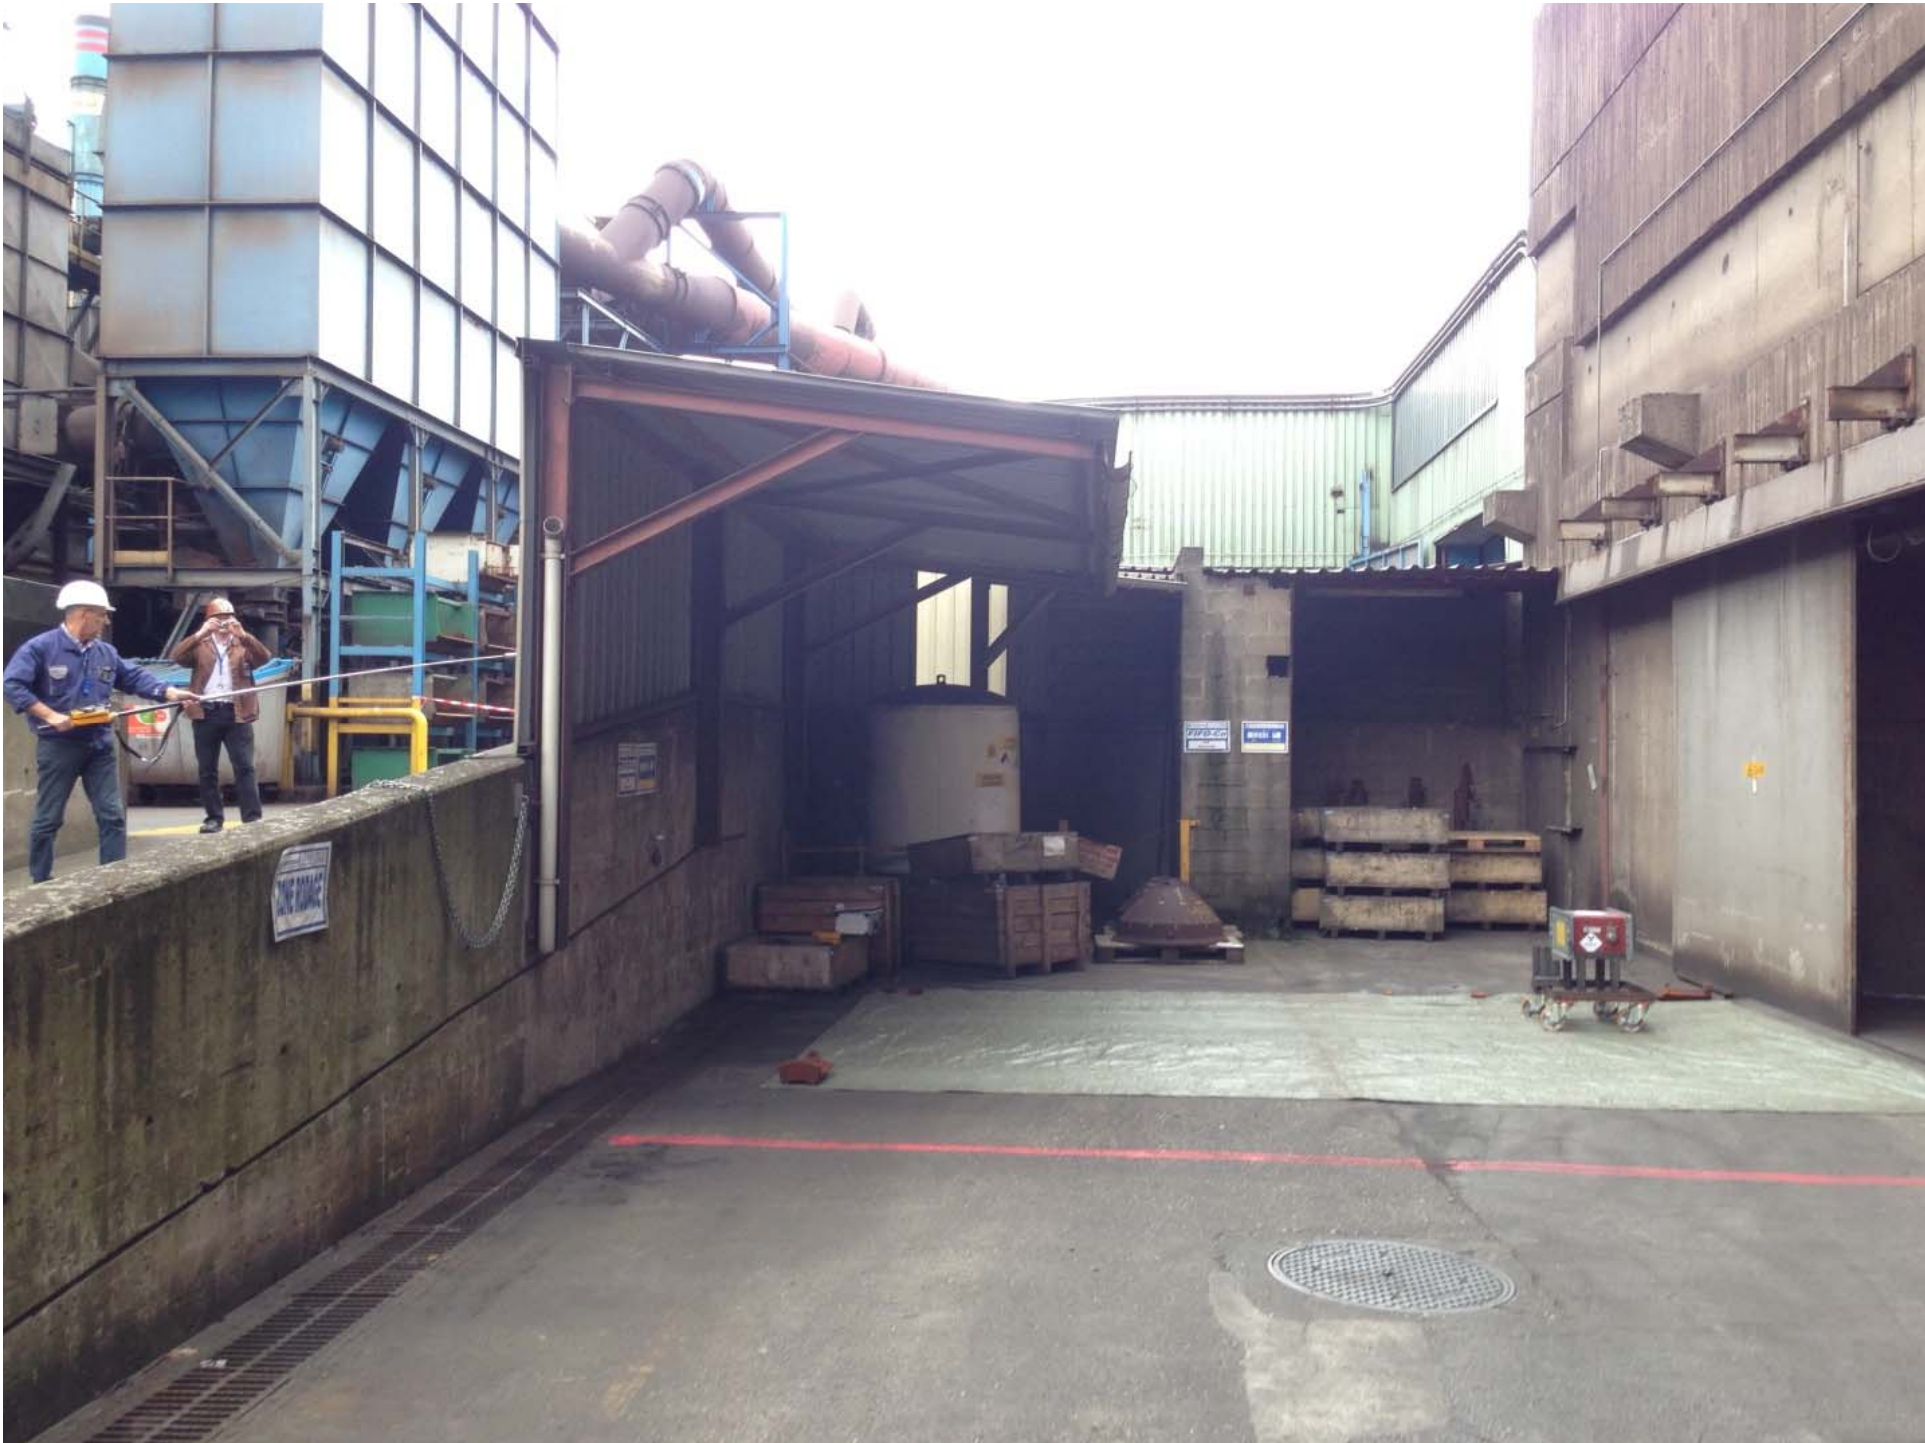
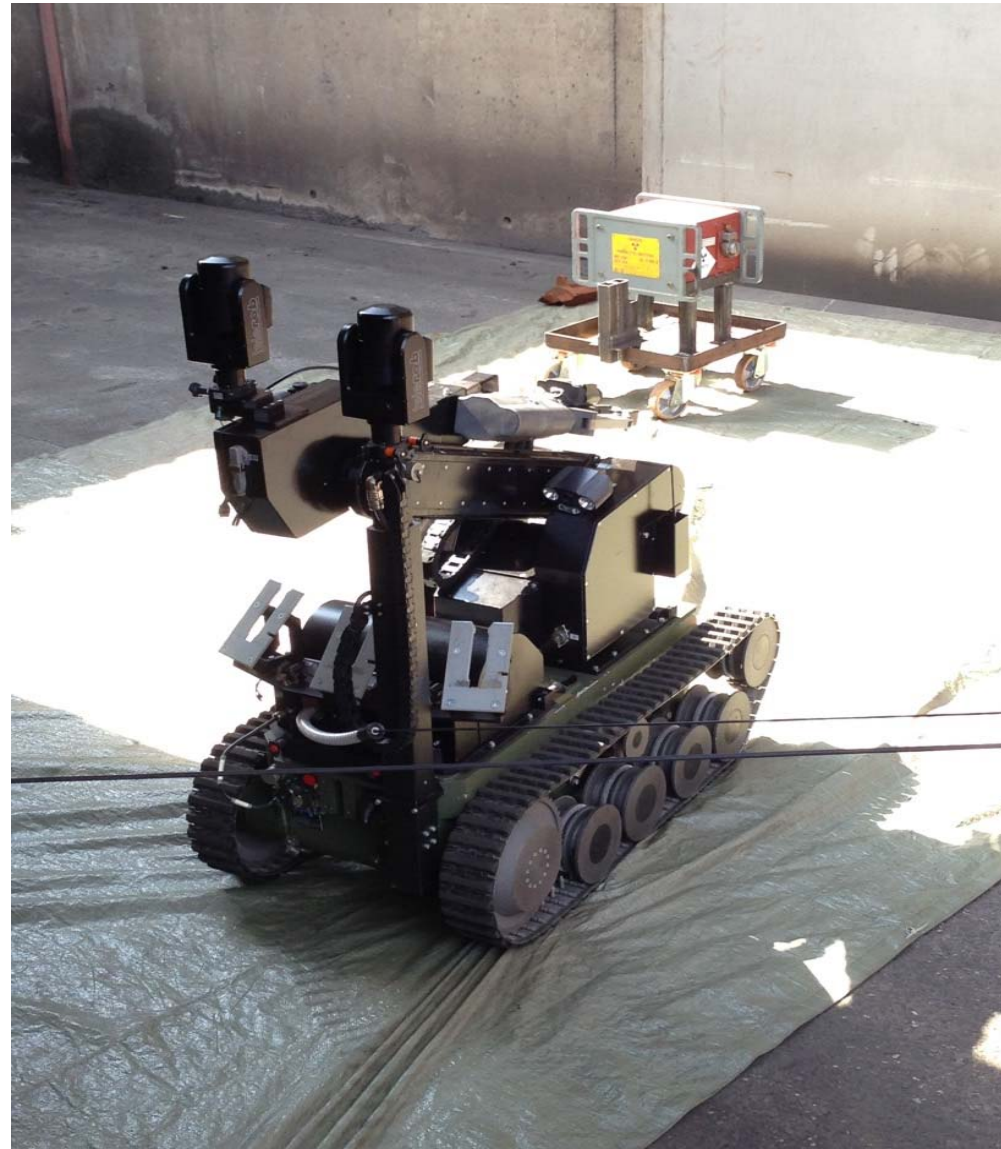
Preparation of
retrieval

Robot entering
the irradiation
vault

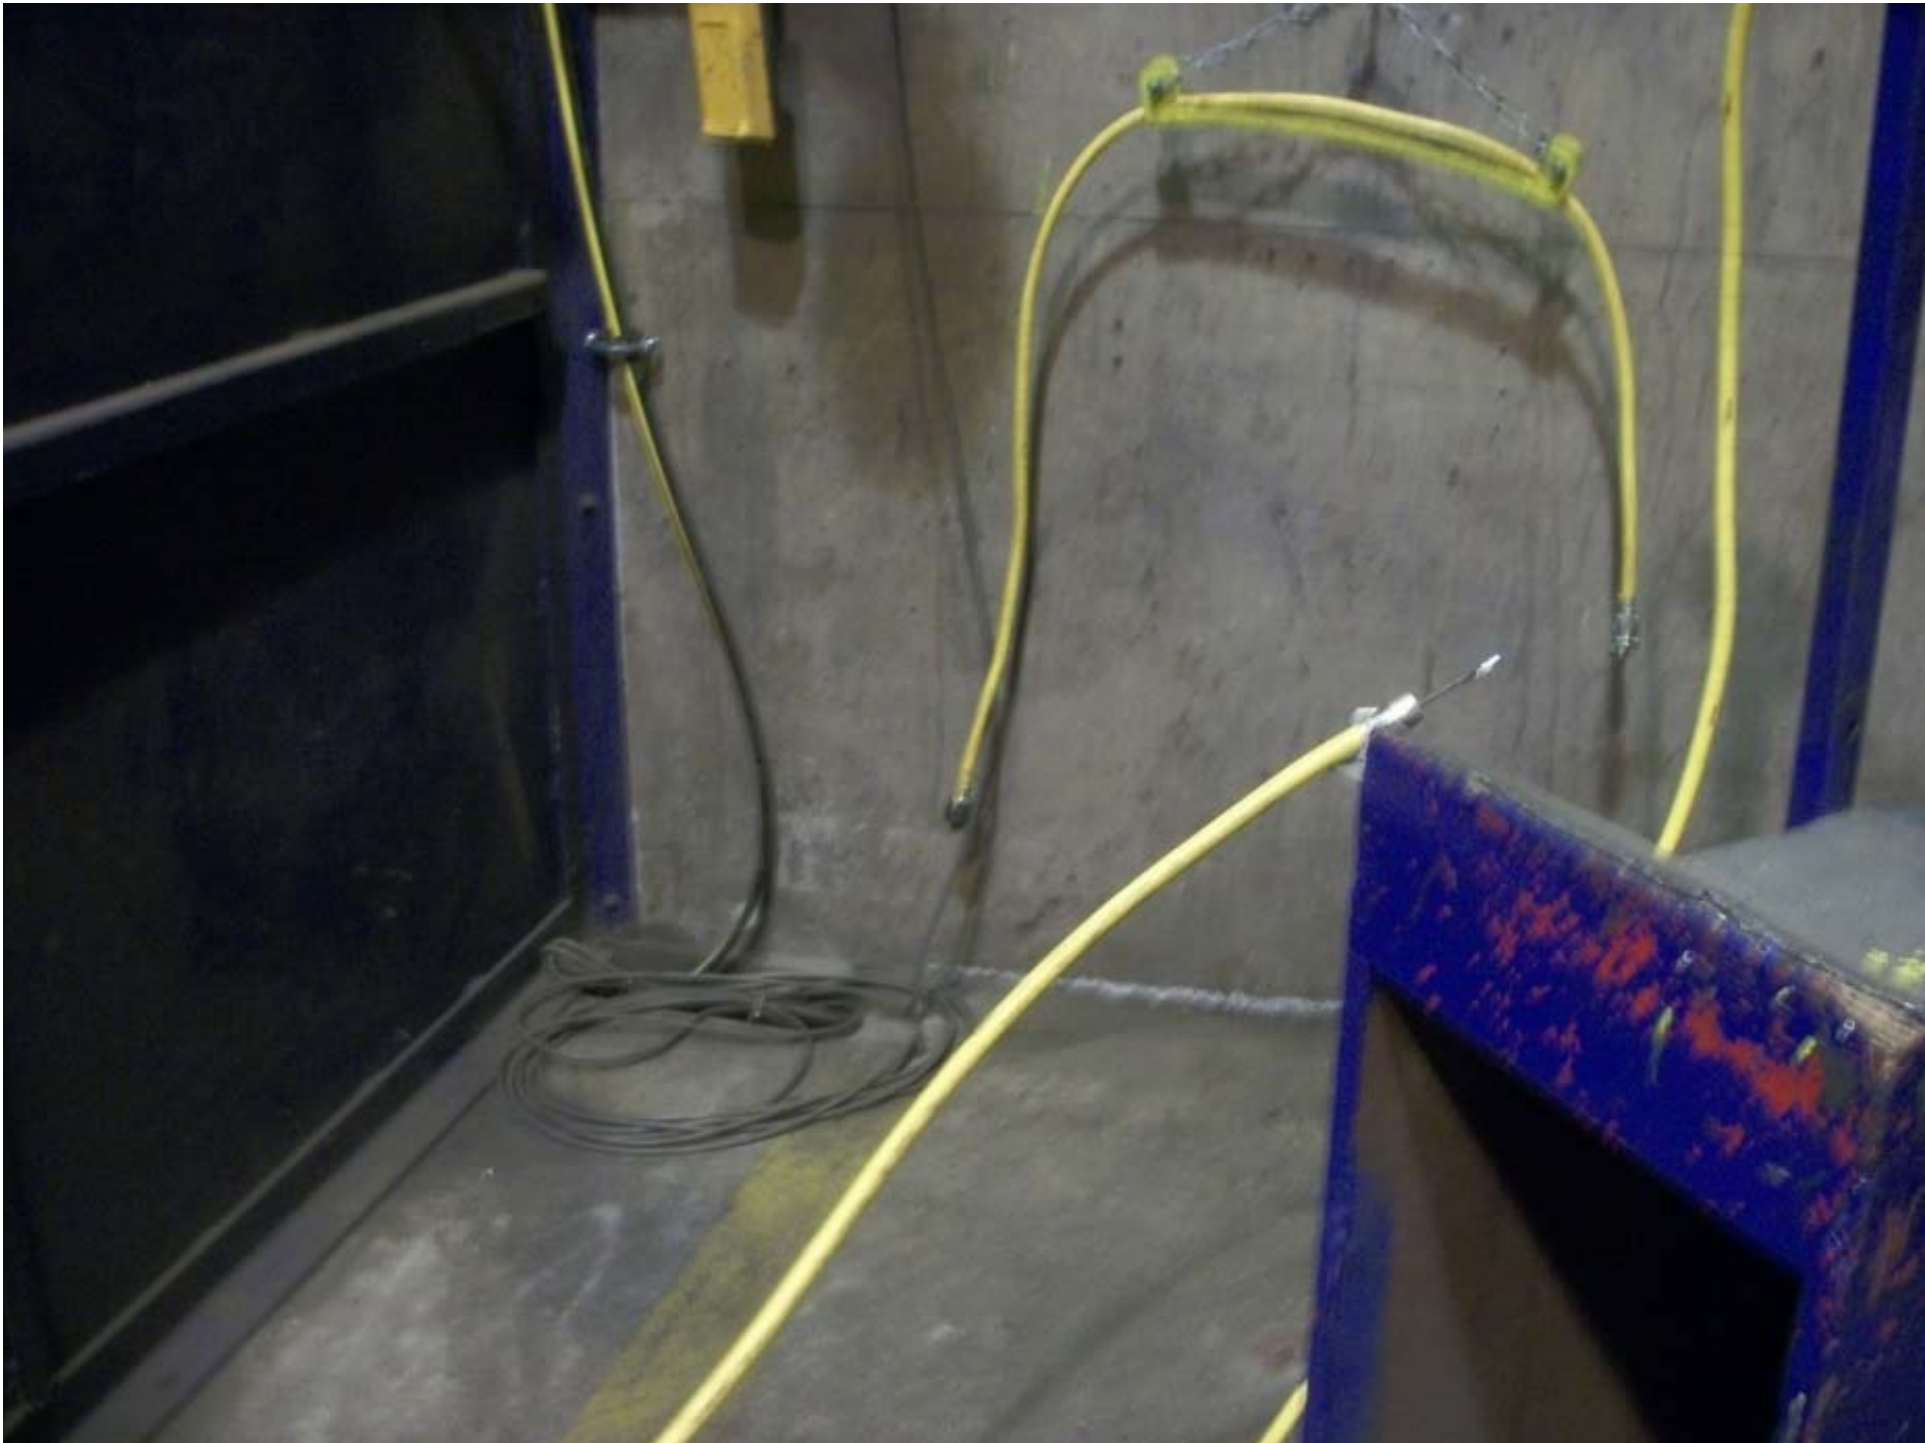
CAUSE:

**Preliminary risk assessment
&
human error**

Operations to put installation back into service 12 – 18 May 2015

1. Complete maintenance of SENTRY 330 container (certificate QSA)
2. Replacement of drive cable
3. Use of new one piece ejection sheets with lock on the SENTRY 330 container
4. Extensive cold tests
5. Coupling of source holder on new cable and reintegration of source in SENTRY 330
