Case study of an accidental exposure to X-rays in industrial radiography

AV Controlatom – certified inspection body in Belgium – www.controlatom.be

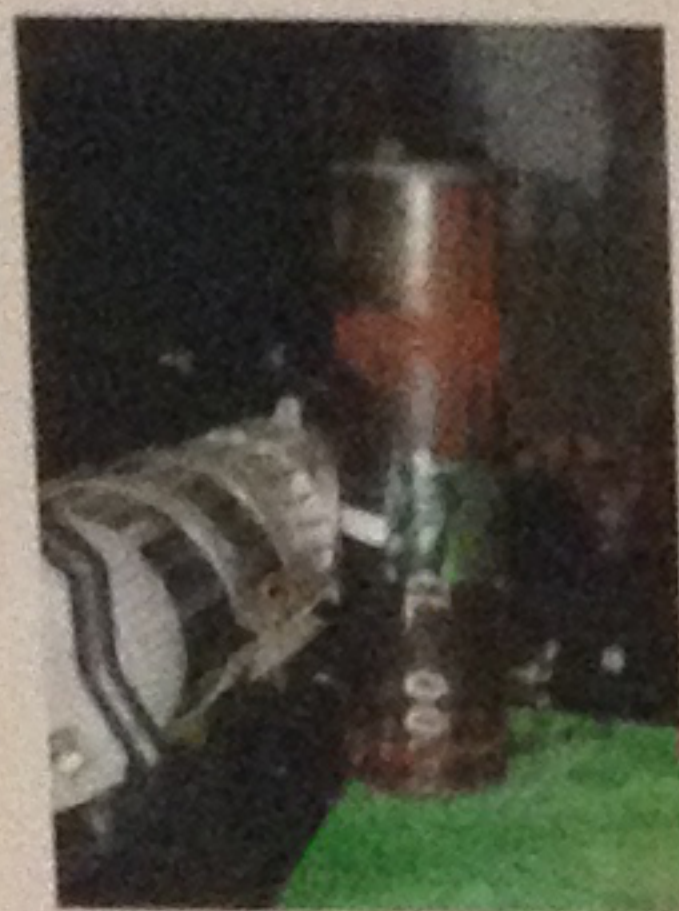
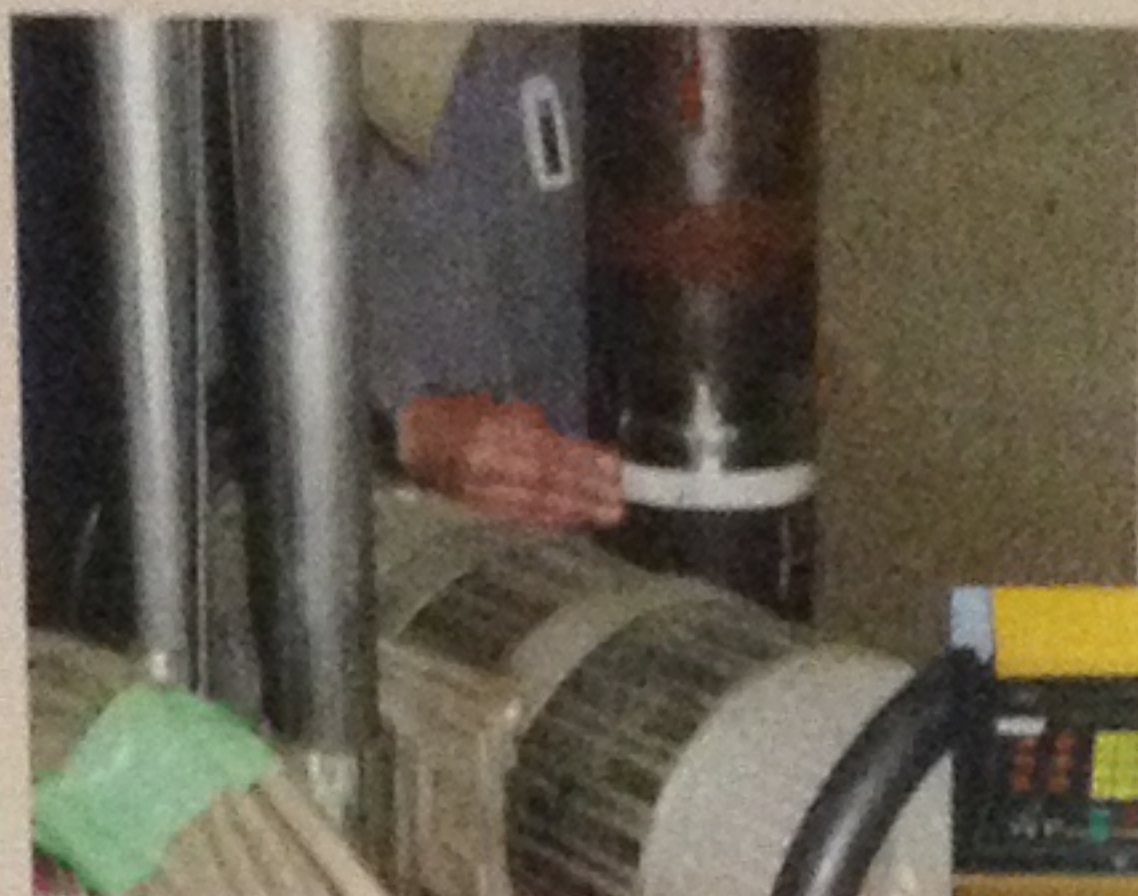
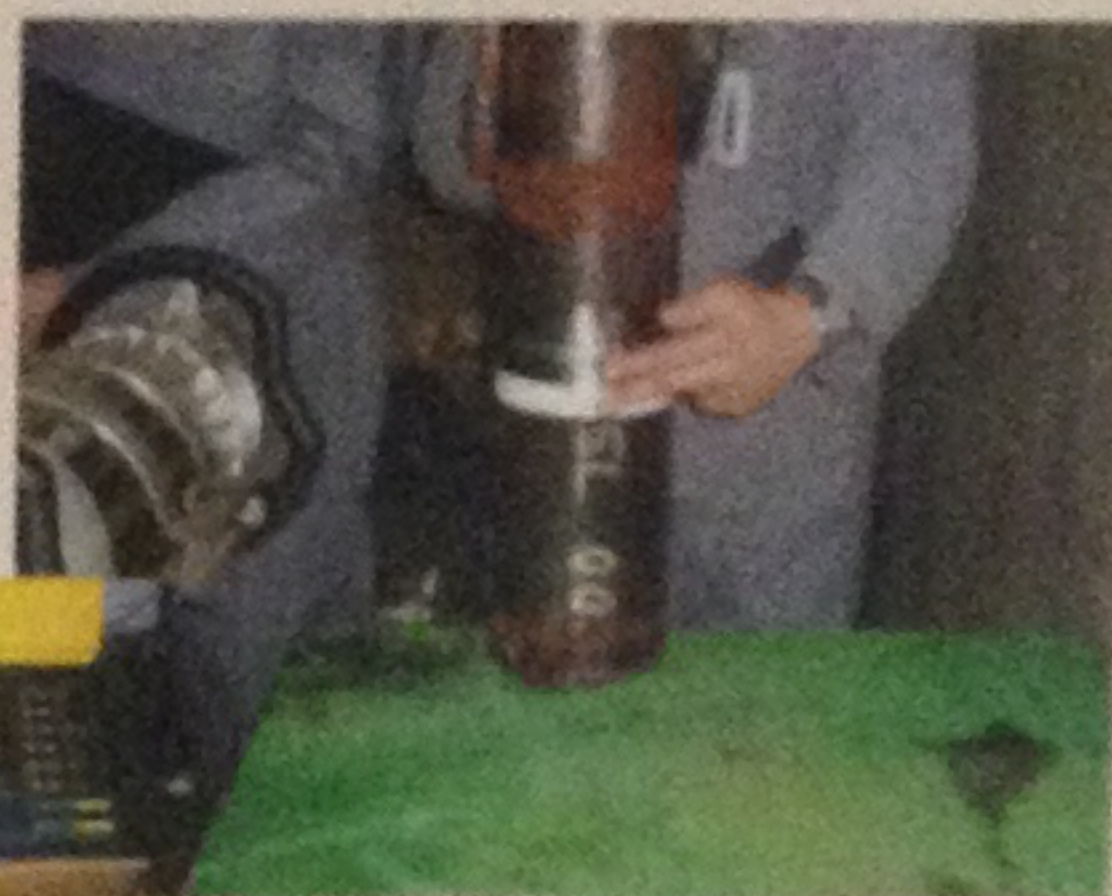
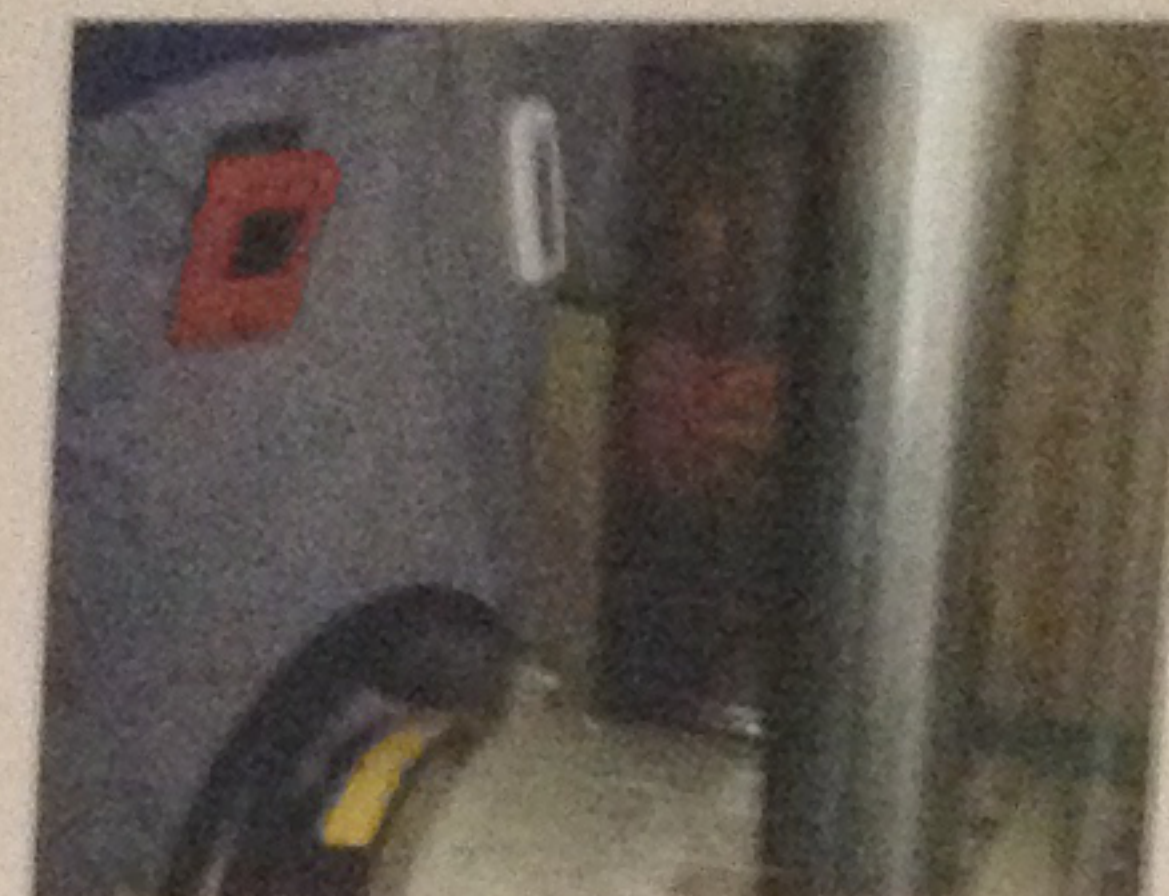
An industrial radiographer replaced a film on a welding test pipe while the X-ray tube he was using became or was still active. The device was malfunctioning at the time (temporary loss of voltage that resulted in longer exposure times).

Lessons learned and actions taken

- The incident was reported to the management two weeks after the incident. So no actions were taken during the two weeks after the incident. This was due to the radiographer's insufficient knowledge of the possible effects of radiation.

- At first the certified physician did not fully comprehend the severity of the incident. This was due to a limited communication concerning the details of the incident.

- The radiographer has a work prohibition issued by the certified physician for the use of sources of ionizing radiation for 18 years (360 mSv divided by the dose limit of 20 mSv per 12 months).

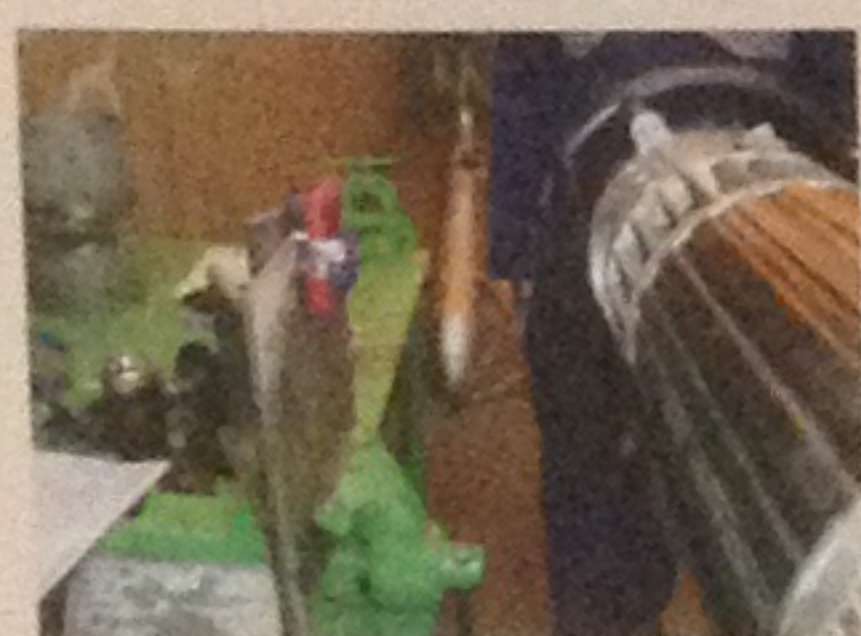
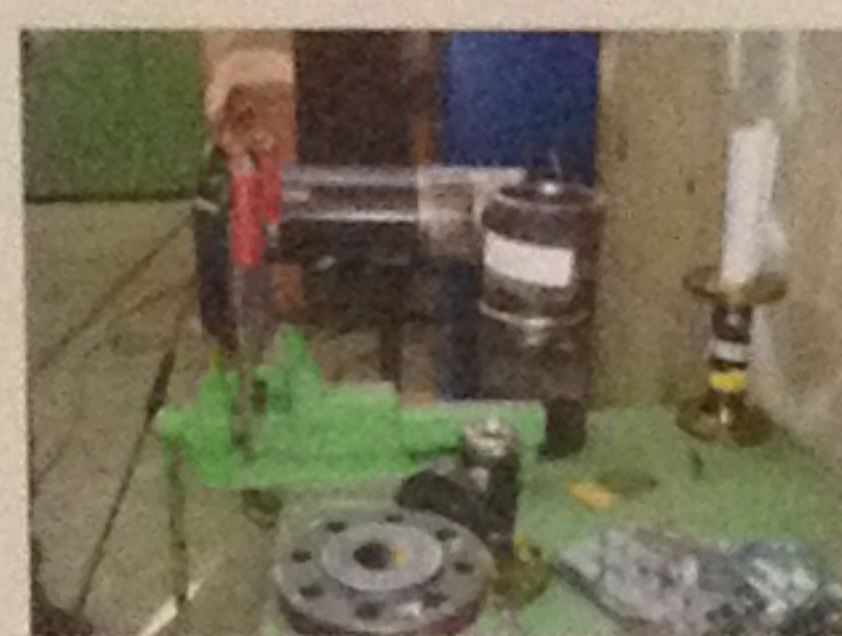
Test of PED and OSL (225 kV – 4 mA during 15s)

Scenario 1: dose in the beam

30 cm :	OSL: 339 mSv	Tracerco: 2350 mSv
100 cm :	OSL: 41 mSv	Tracerco: 2350 mSv

Scenario 2: dose by scattered radiation (50 cm between detector and pipe)

OSL: 0,94 mSv	Tracerco: 2000 mSv
---------------	--------------------

Based on (1) the fact that we are uncertain about how and where the OSL badge and the PED were worn during the incident, and (2) the unreliability of the PED when exposed to a high dose rate (up to 100 Sv/h at 30 cm of the X-ray tube) it was decided to only use the result of the biological dosimetry.
