Gamma radiography source recovery equipment

16th European ALARA Network Workshop

Stefan Büchi, Suva, Bereich Physik

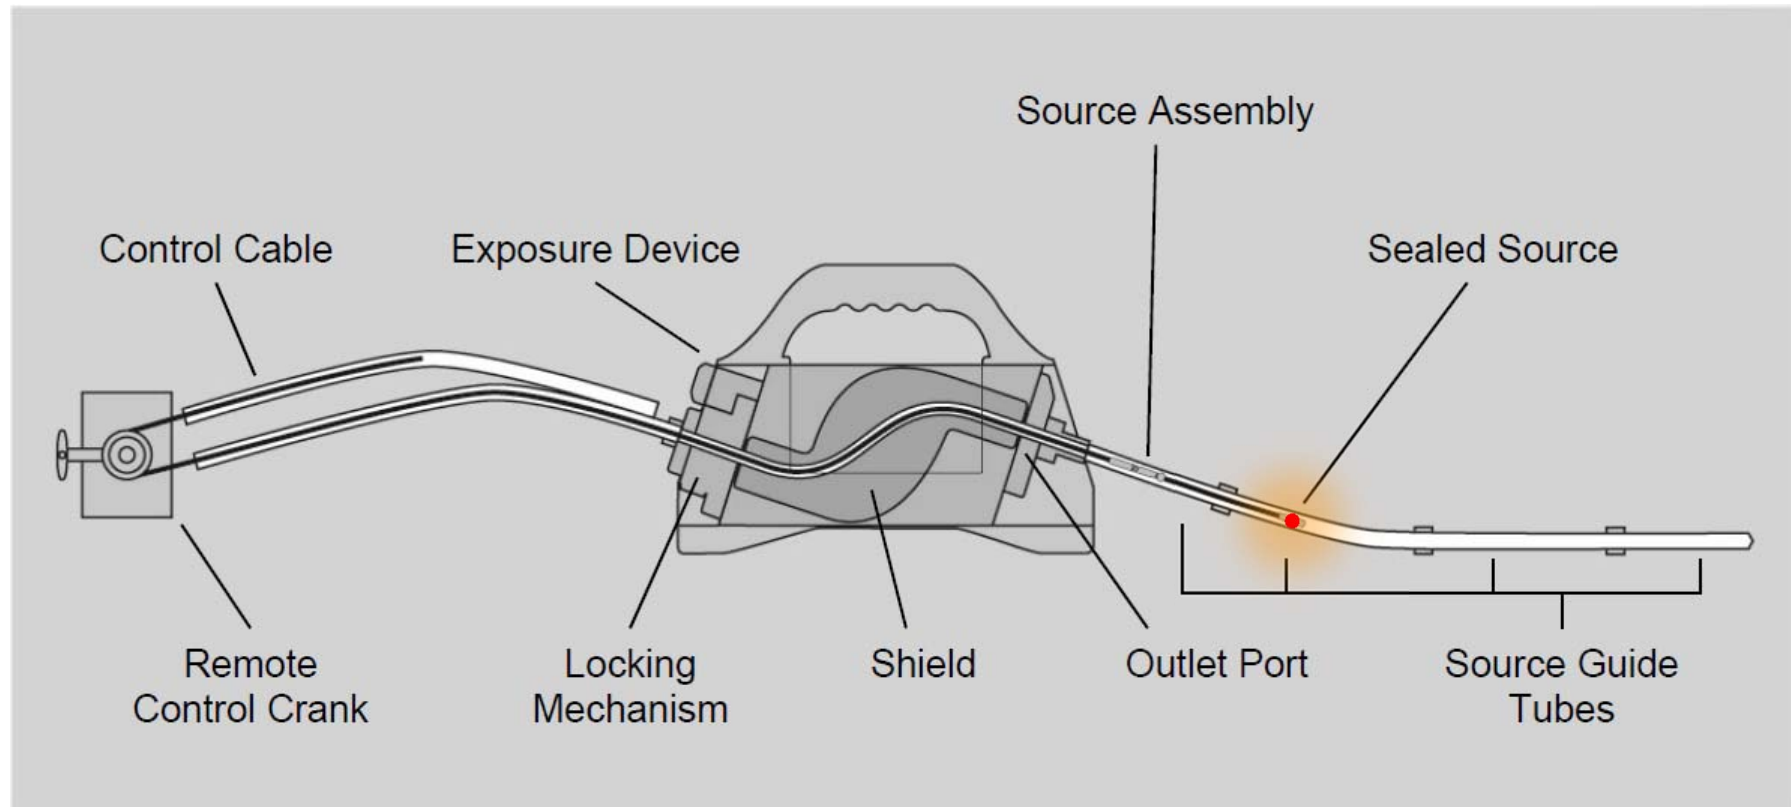
Radioactive source stuck in the guide tube — overview of the situation

Source: www.qsa-global.com Model 880 Series Source Projector Manual

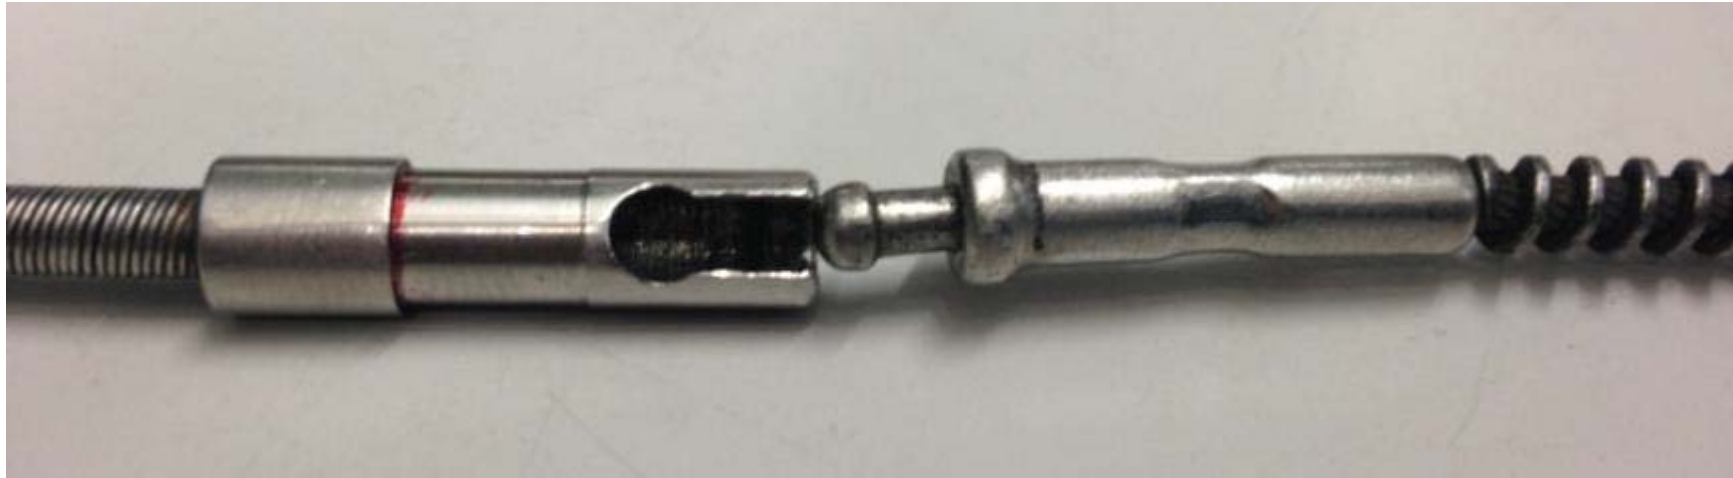
- ◆ Lost connection between source assembly and control cable: Source can be pushed forward but not retracted.

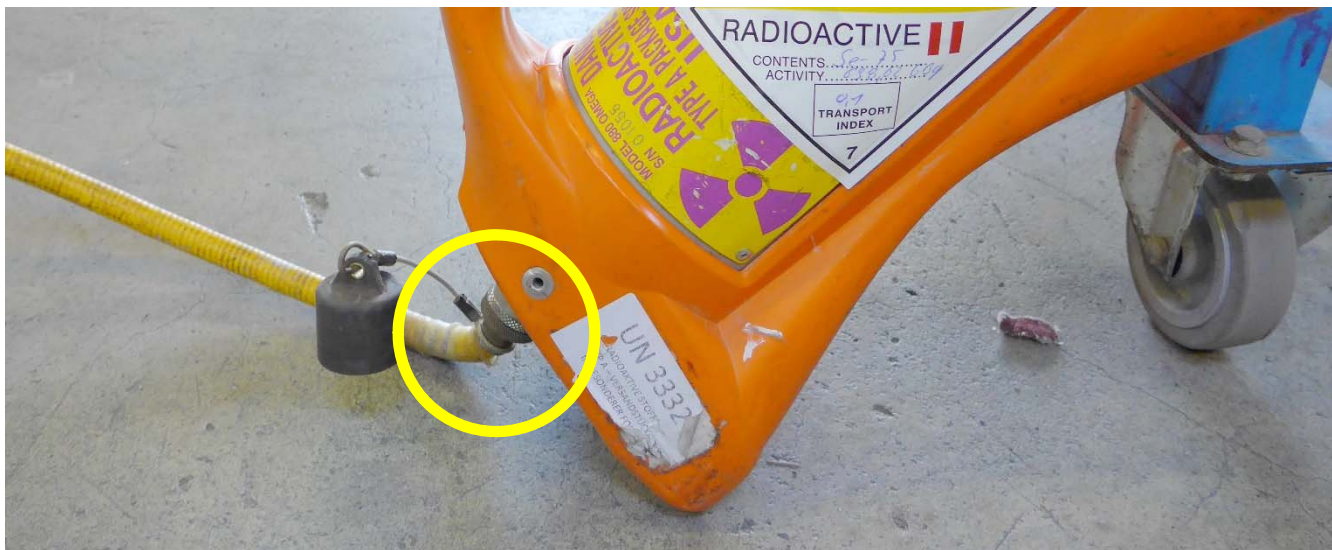
- ◆ Guide tube squeezed or buckled (hit by the fallen gamma projector or any other object):
 - Source can neither be moved forward nor backward.
 - Source can be retracted no further than to the point where the source assembly reaches the squeezed or buckled part of the guide tube.

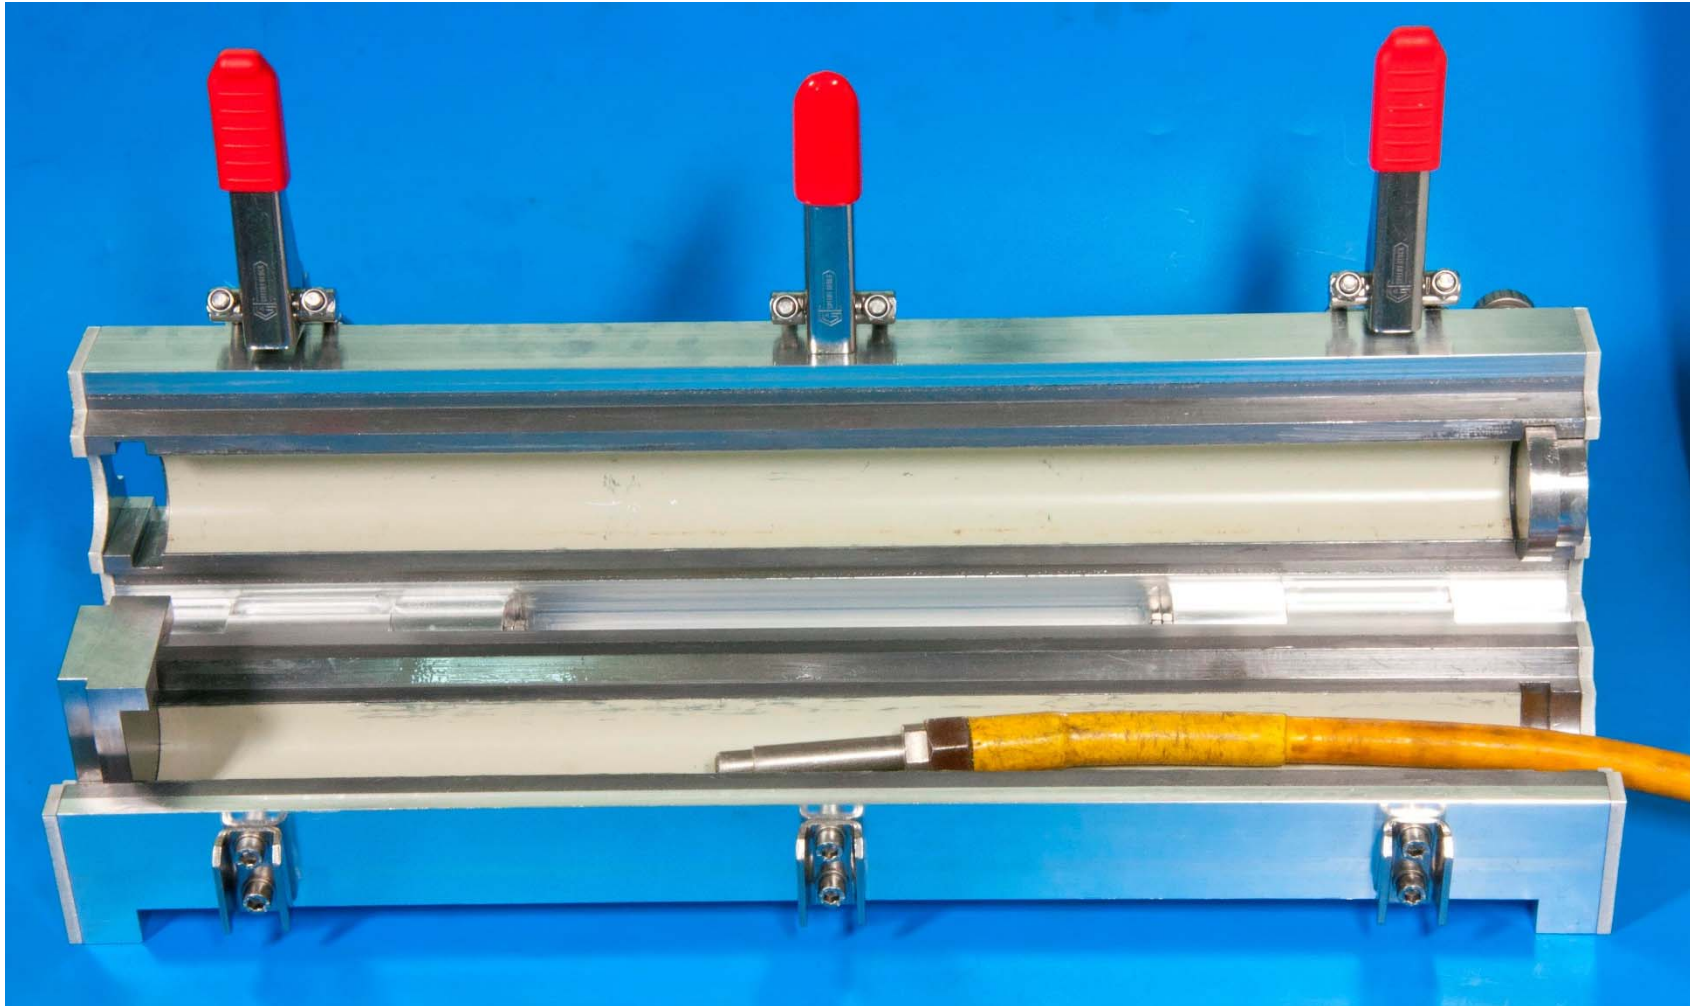
Prototype source recovery container, constructed by Qualitech AG

- ◆ Qualitech AG, a Swiss NDT company, constructed a prototype.
- ◆ Actual figures of the prototype:
 - Attenuation factor: Se-75: **500** Ir-192: **30** Co-60: **~3**
 - Weight: 33 kg
 - Lead shielding: 20 mm
- ◆ Rugged design:
 - Lead shielding in the shape of two halves of a cylinder, each embedded in an aluminium block for mechanical stability and hinged together.
- ◆ Easy handling:
 - Because the two parts are hinged together, the container can easily be closed.

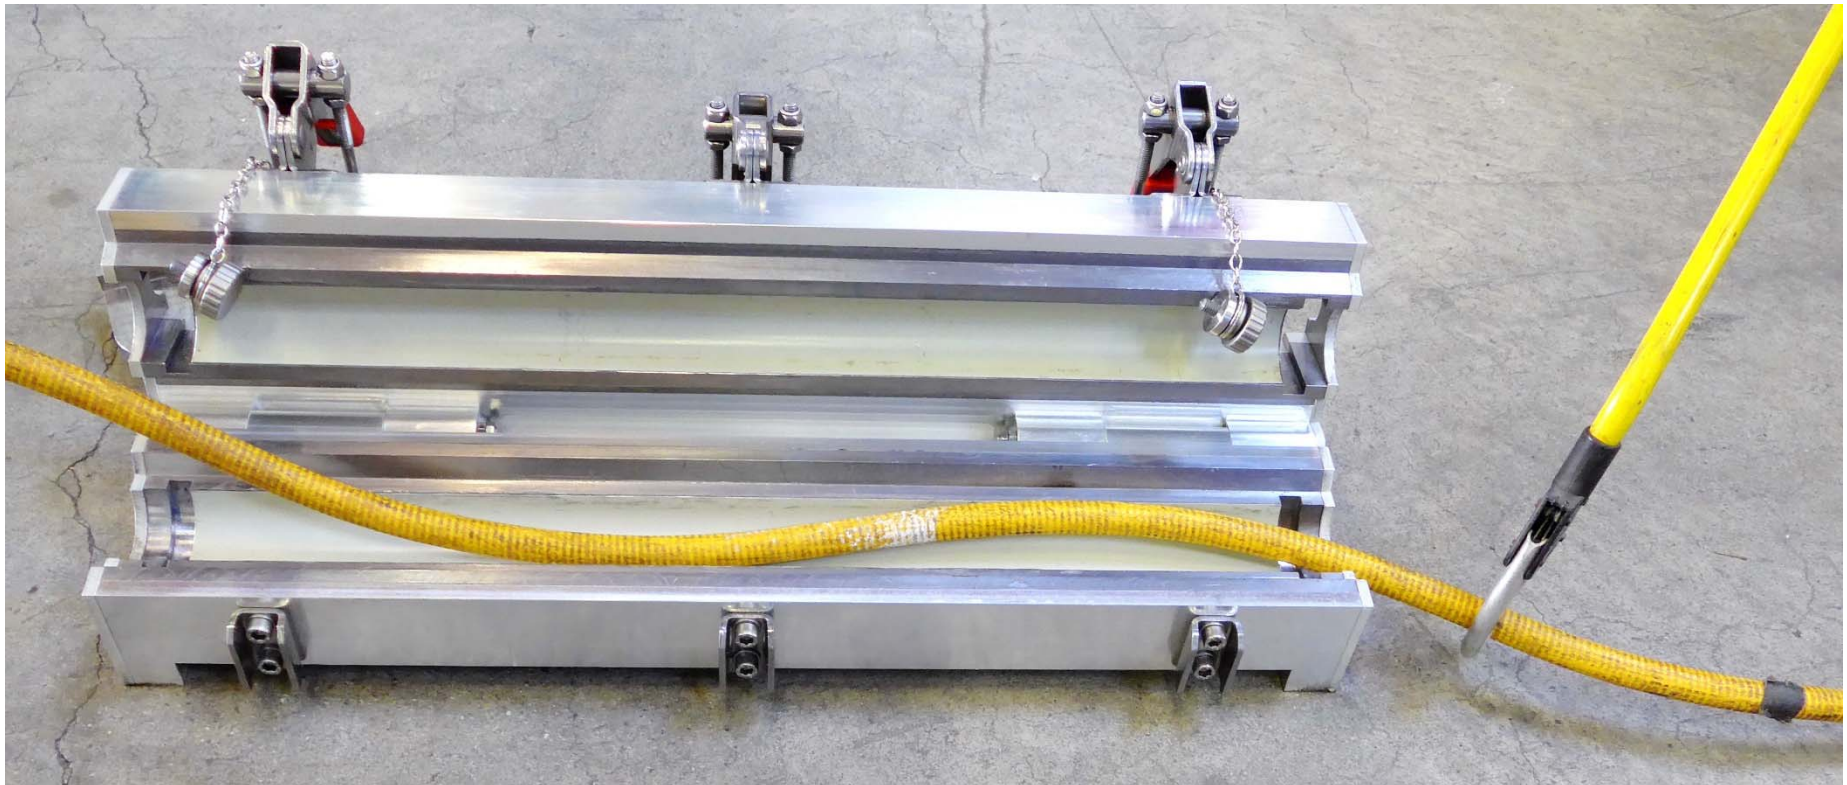
1. Place the open container parallel to the guide tube (not close to the stuck source).
2. Place the guide tube into the lower half cylinder using gripping pliers.

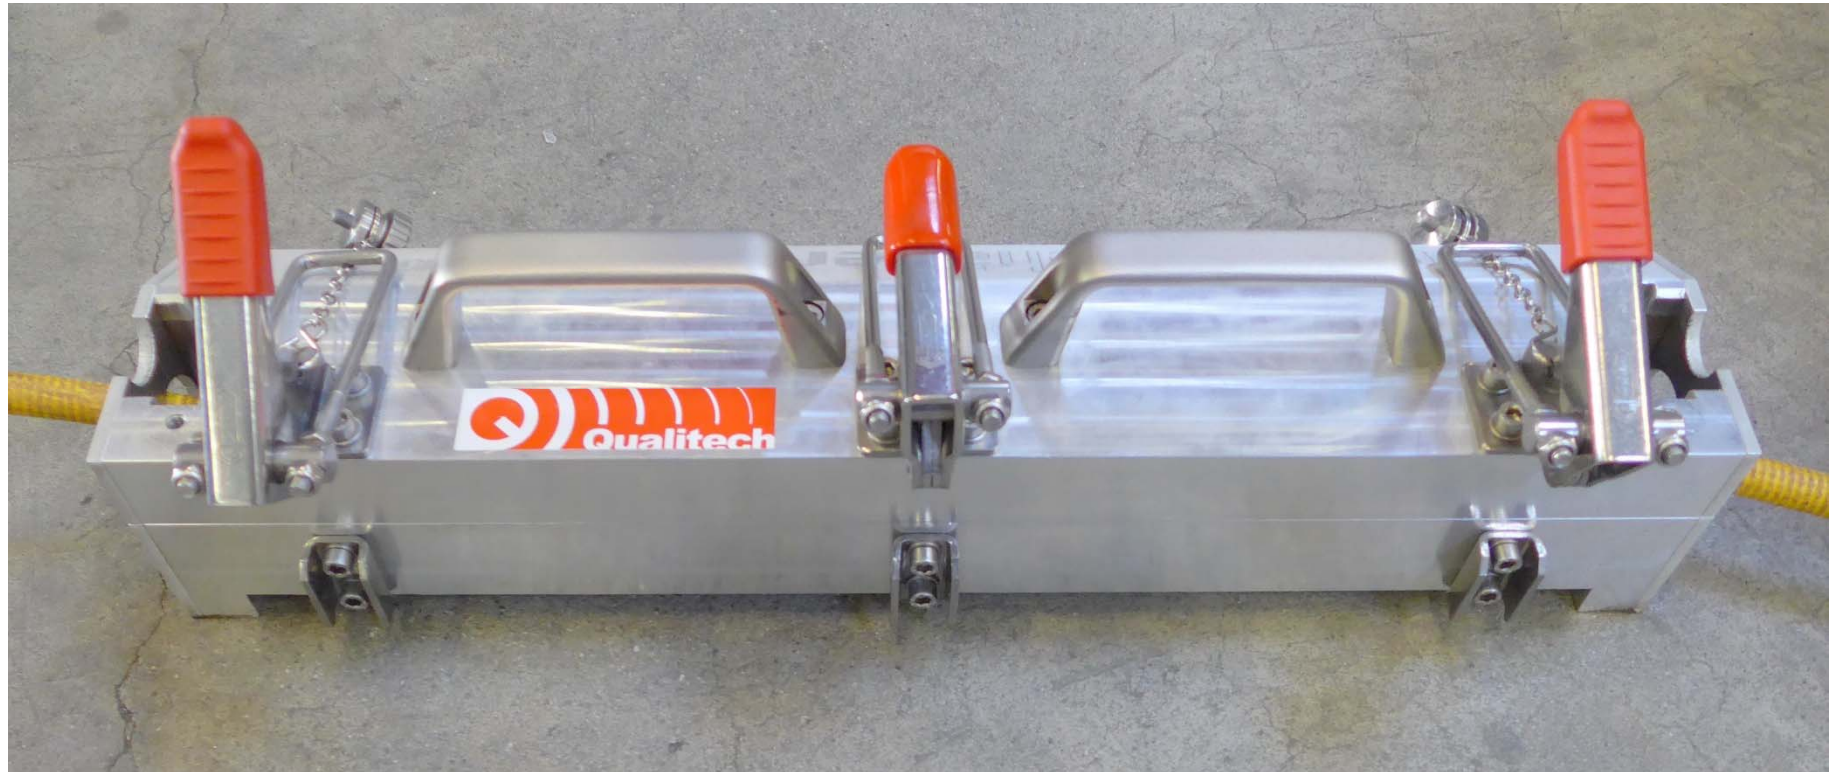
3. Close the container.

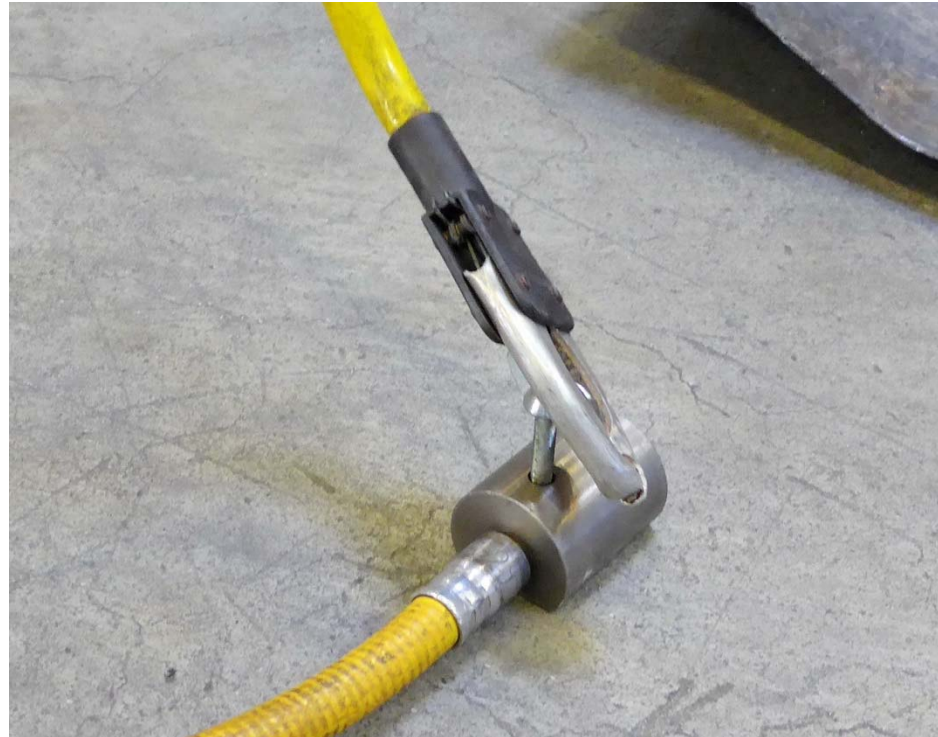
4. Remove the collimator, if necessary.

5. Pull at the guide tube in order to move the source into the container.

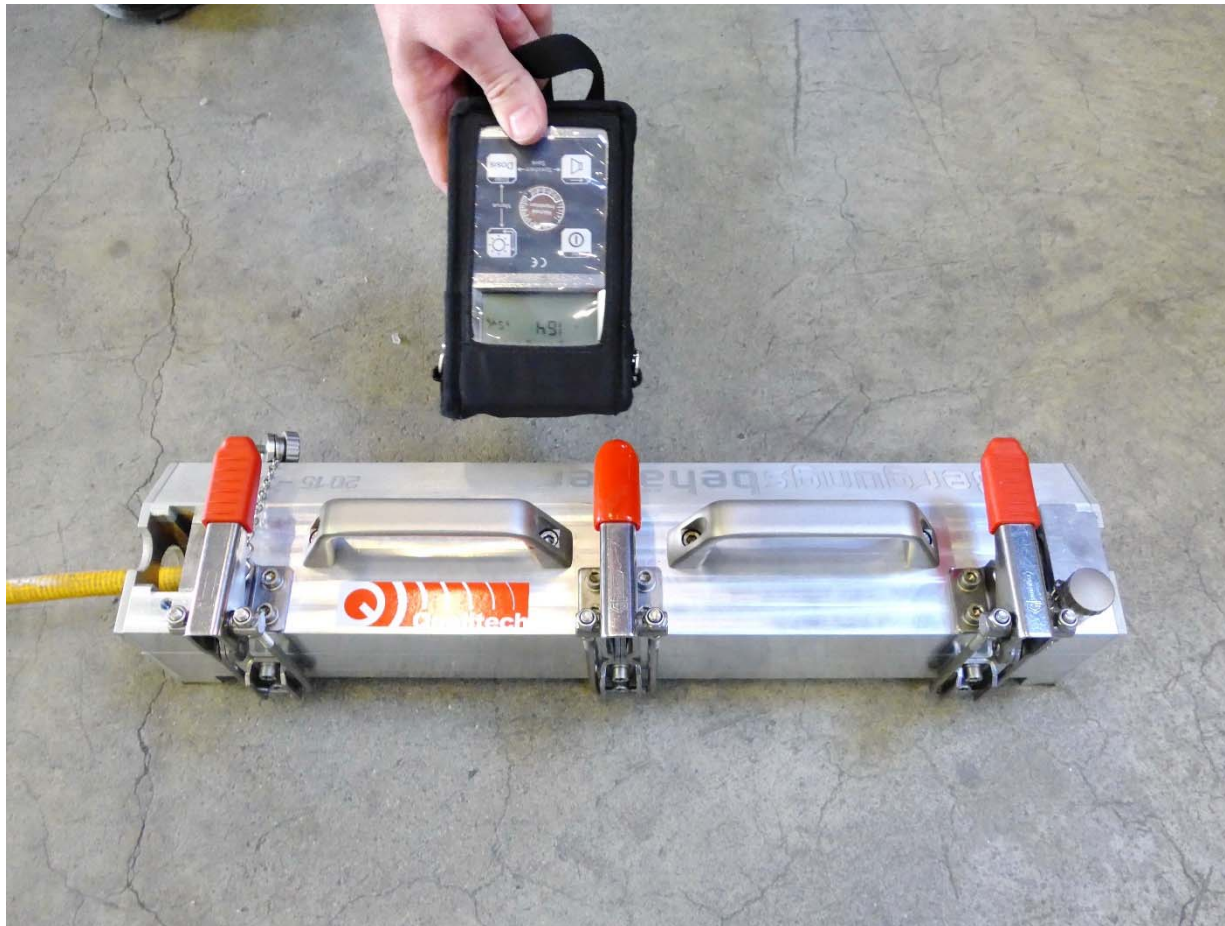
6. Verify the position of the source by measurement. Use a telescope measurement device, if dose rate is high.

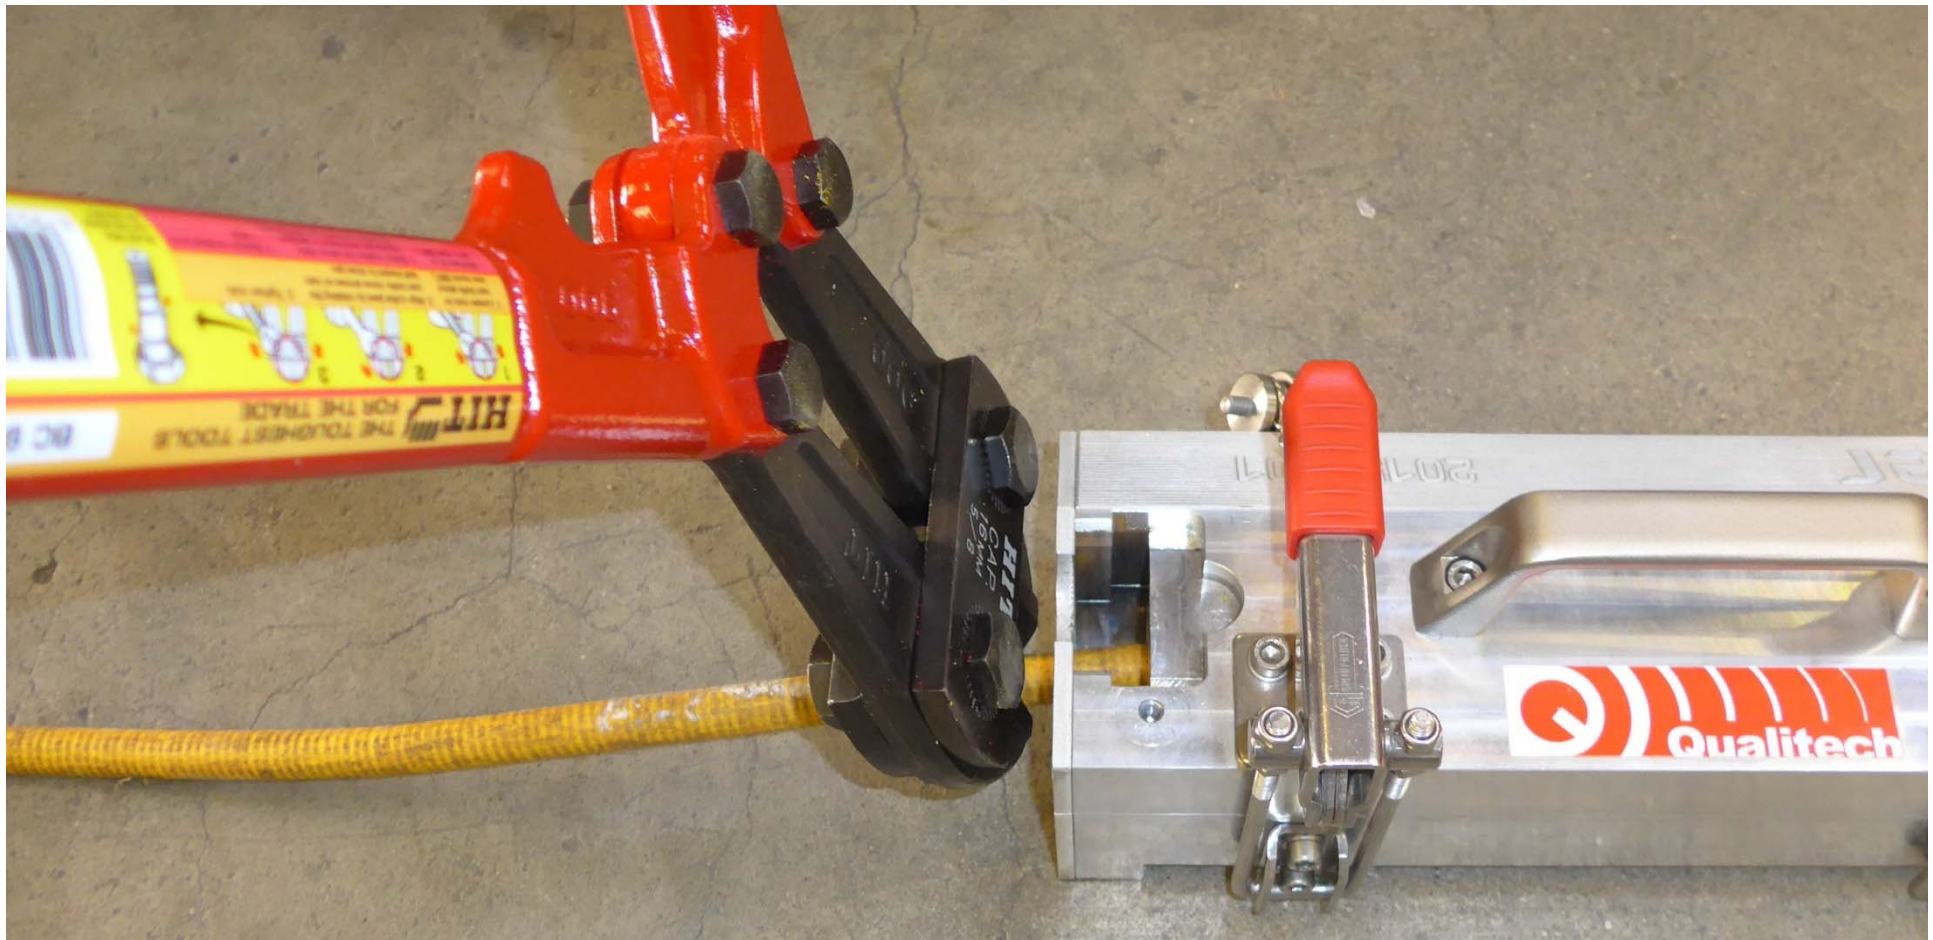
7. Cut the guide tube with a bolt cutter.
Reconsider: Is this unavoidable?

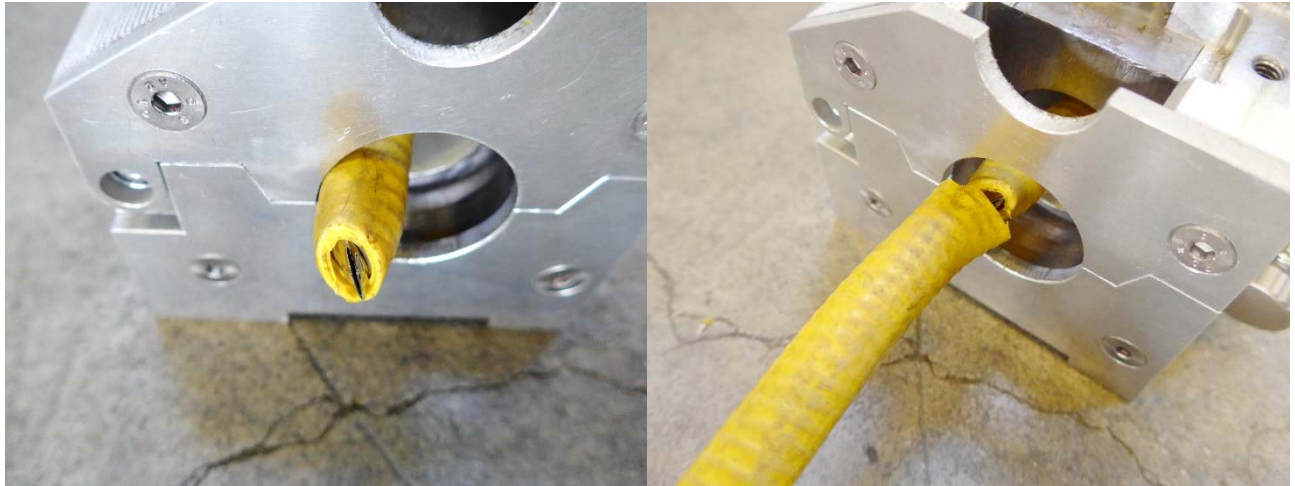
8. Push the cut end of the guide tube into the container.

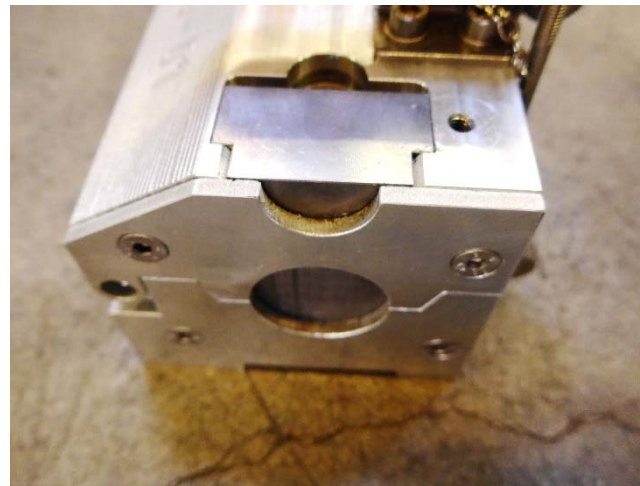
9. Insert the lead shield piece.

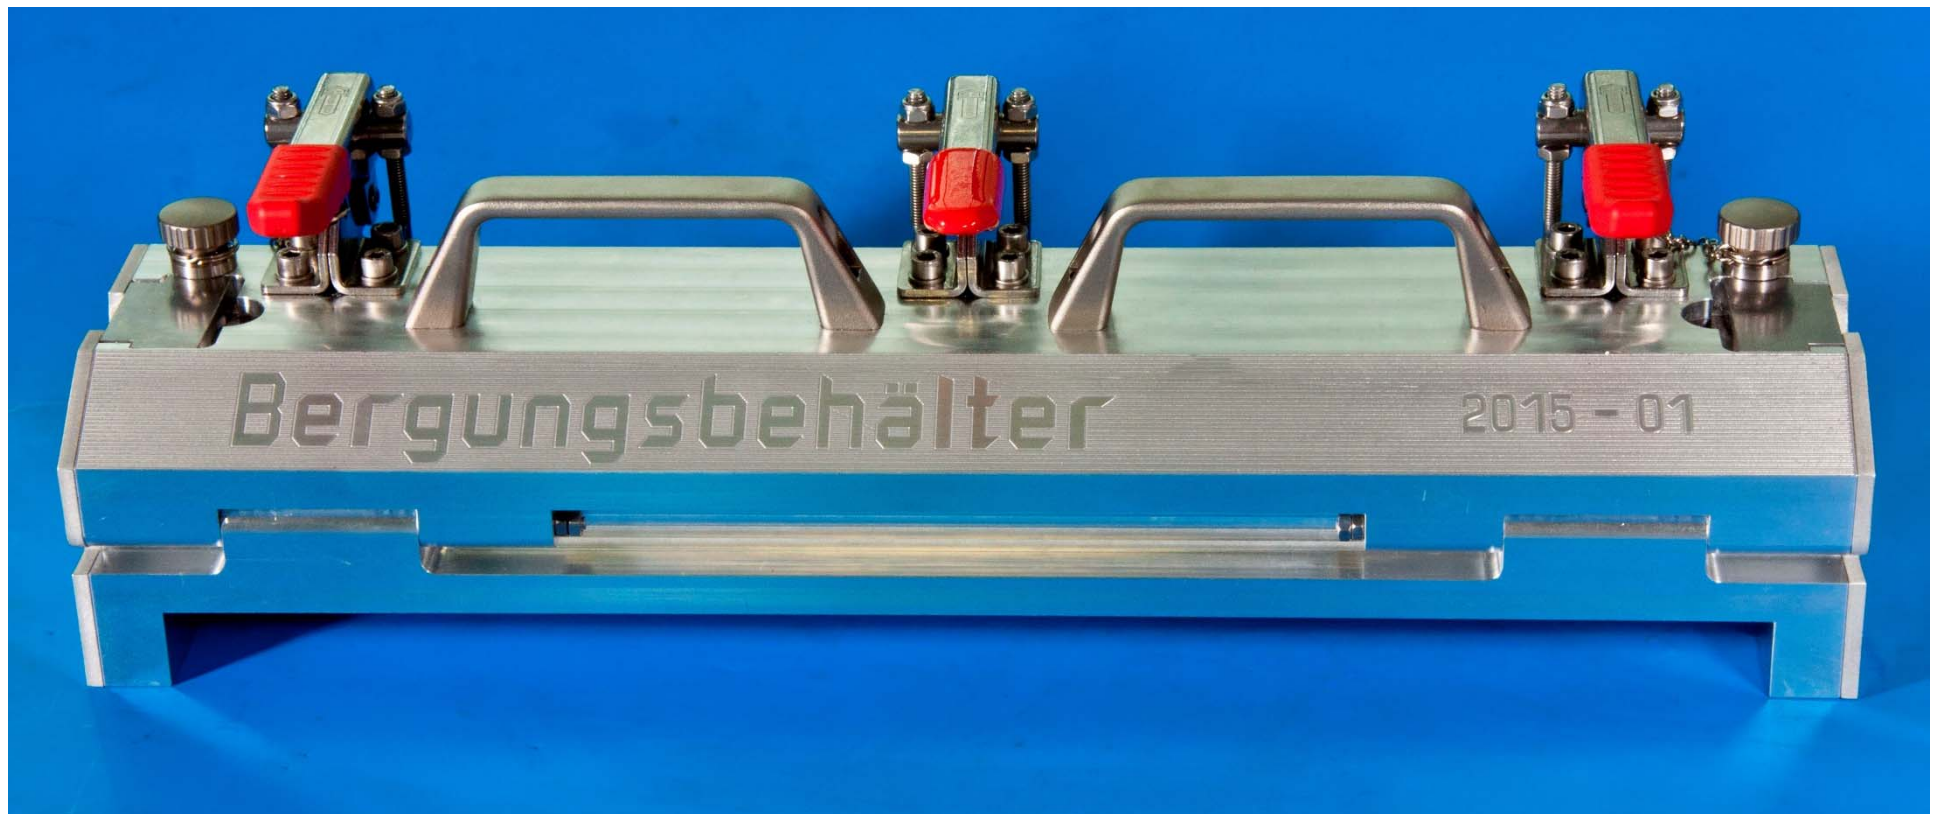
10. Verify that the container is closed and the lead shield pieces at the front end and at the back end are fixed.

The container is ready for transport.
