Radiography incident in Belgium

- Recovery of a Co-60 source in a foundry

Rutger Berden

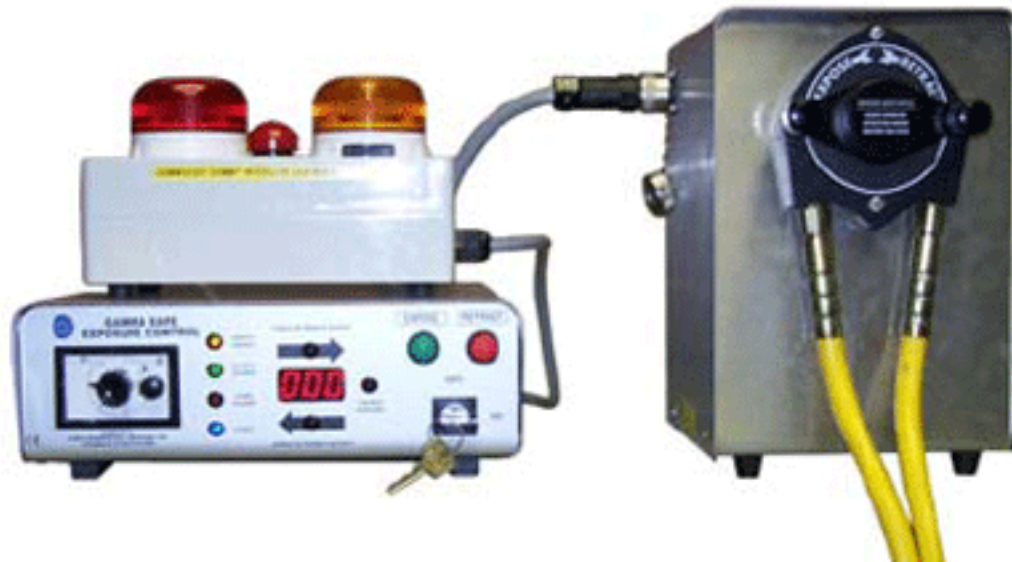
Automatic wind in/out

- ➔ Installation 15 January 2015
- ➔ Automated manipulation of the source

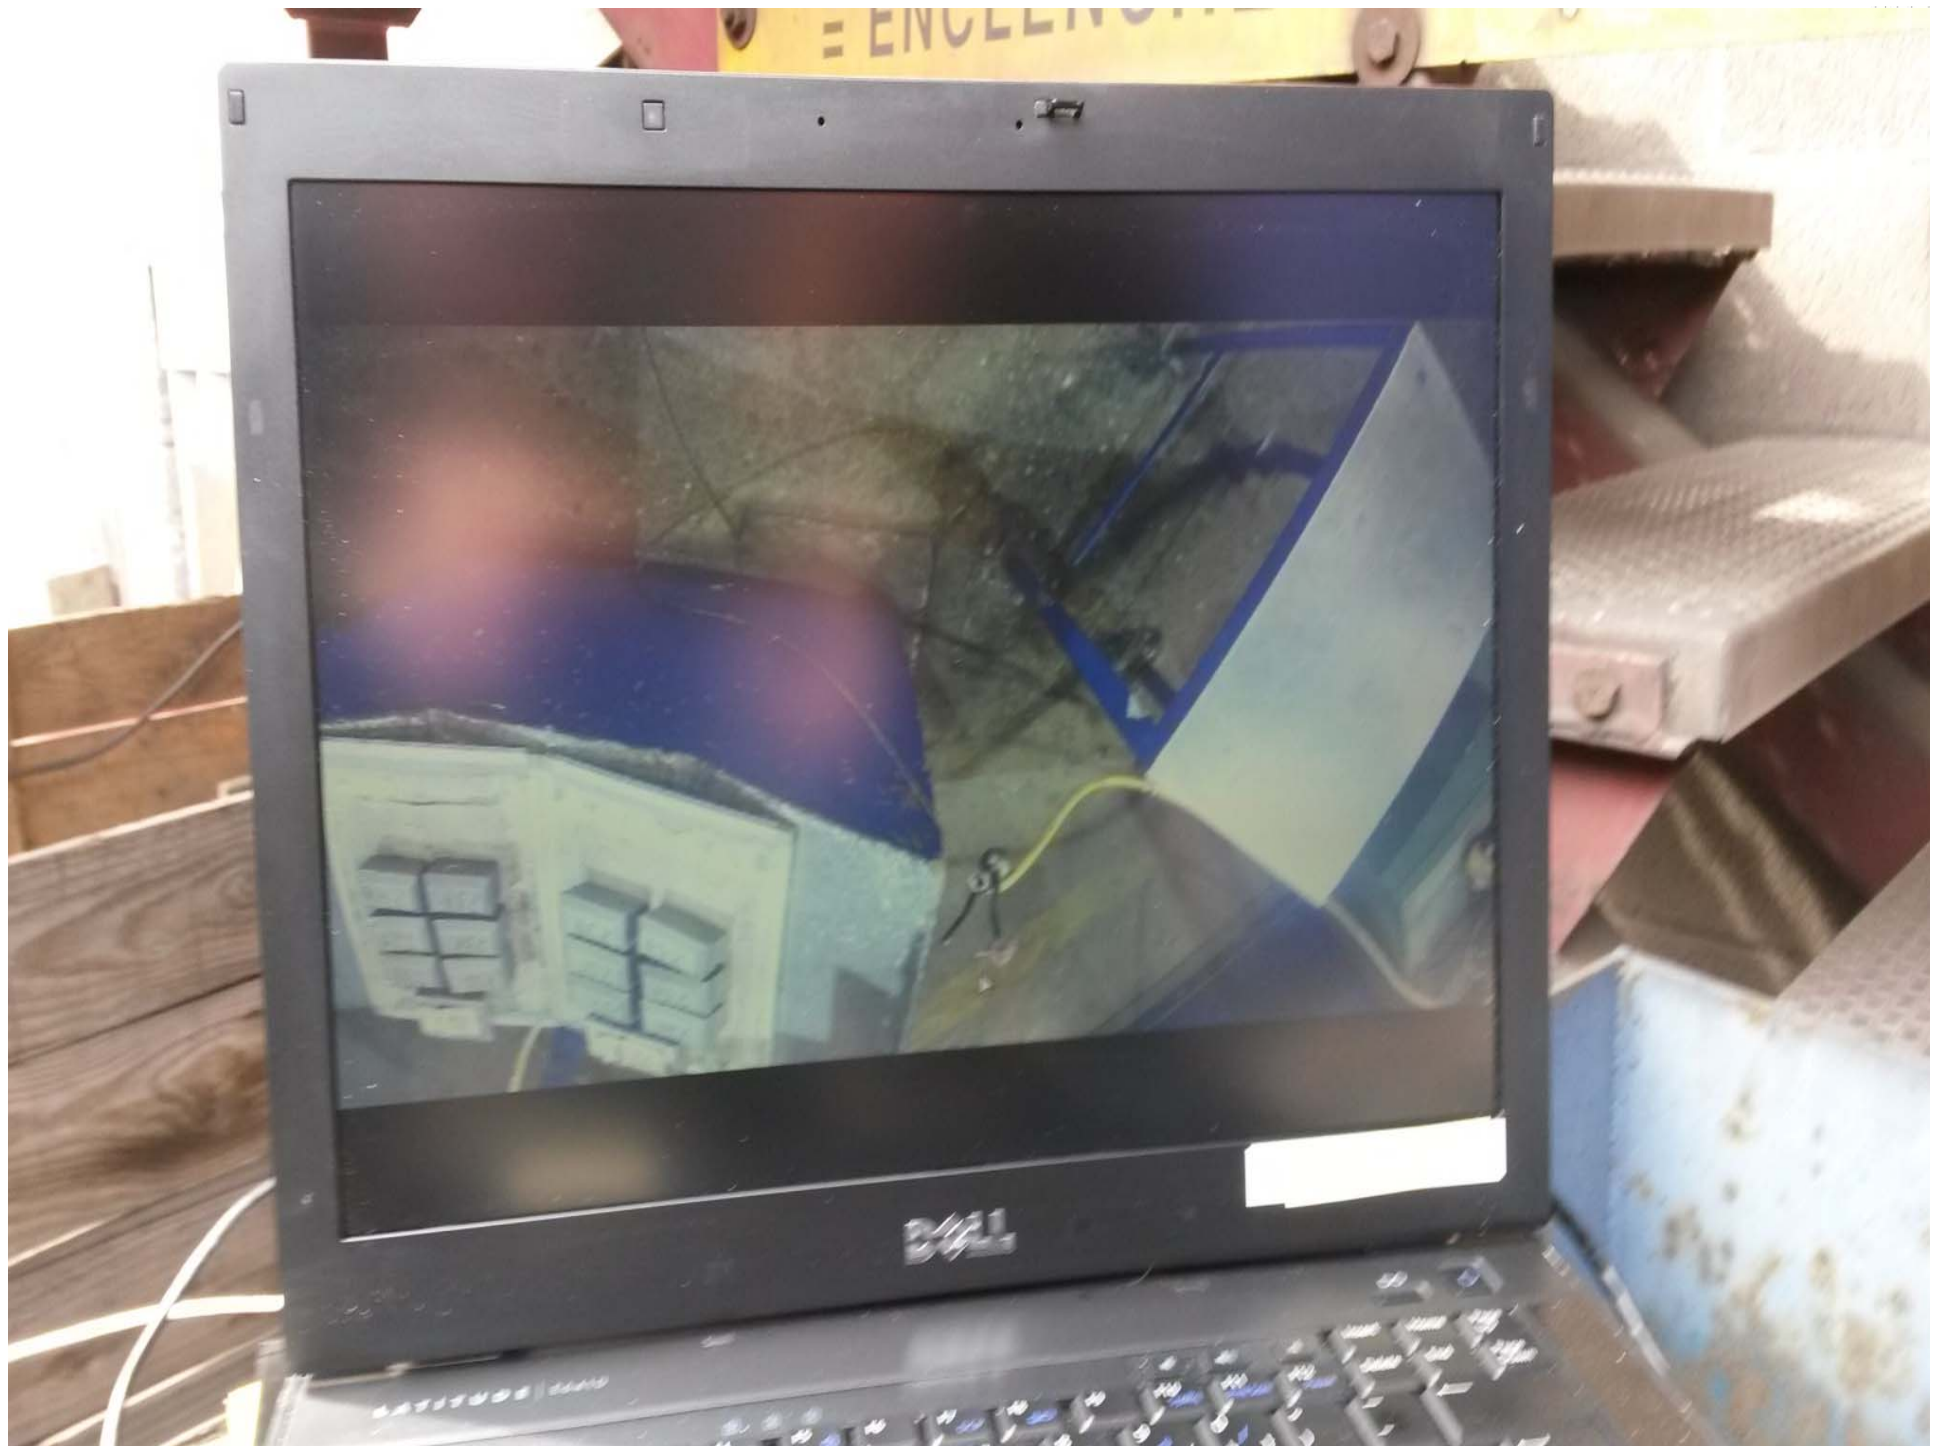
- ✓ 10h30: source blocked outside the container
- ✓ No exposure of operators or public
 - ➔ security devices worked properly

- ➔ Ejection sheet unblocked, but source remained outside container.
- ✓ 15h22: Notification FANC

35 $\mu\text{Sv/h}$ →

350 $\mu\text{Sv/h}$ →

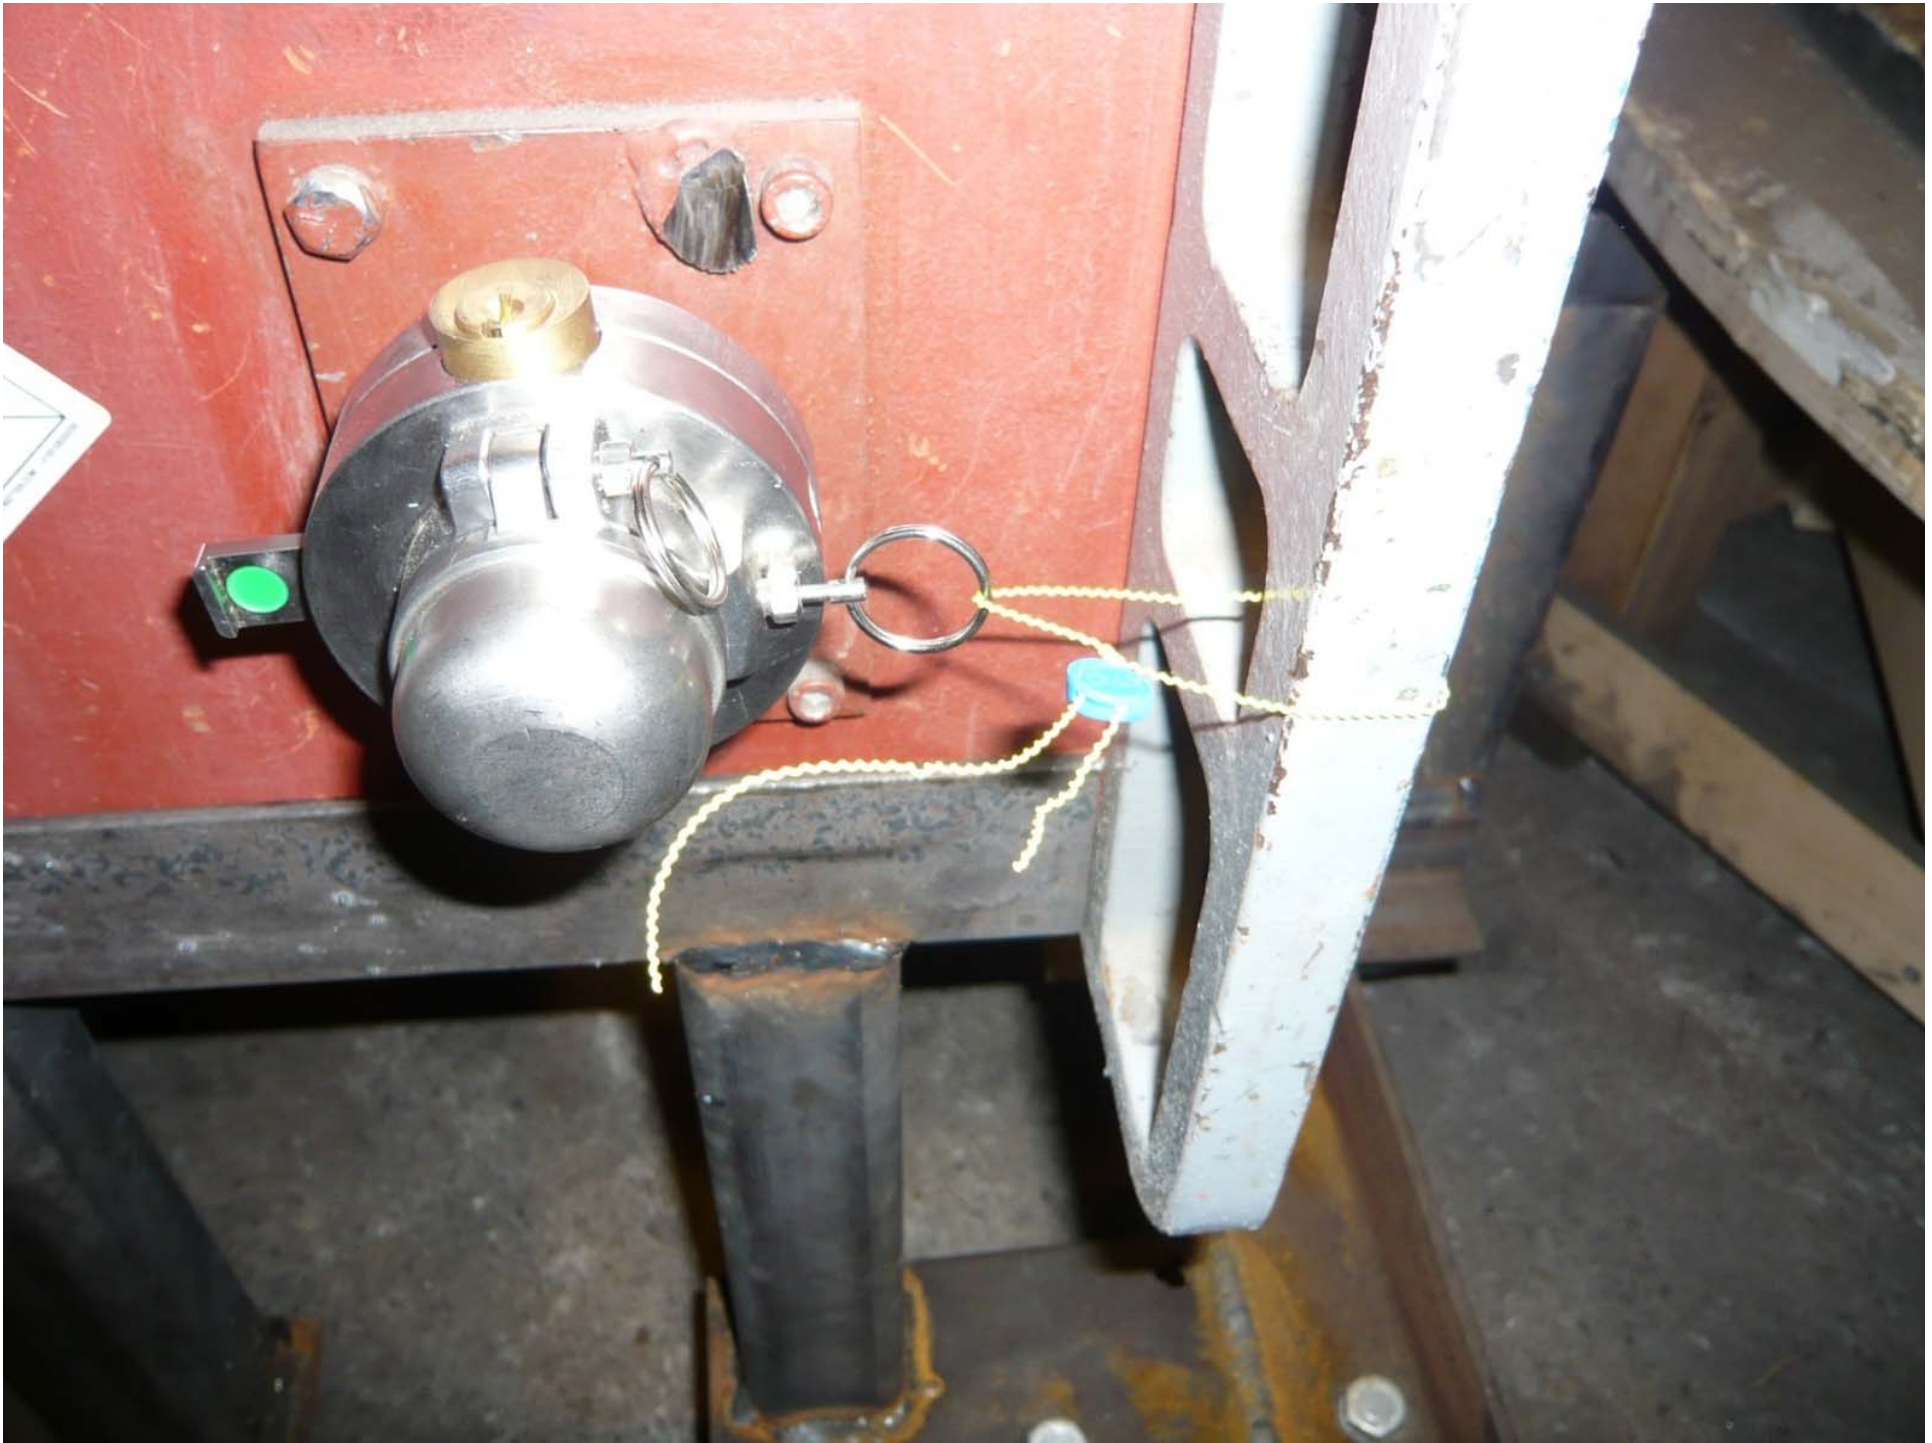
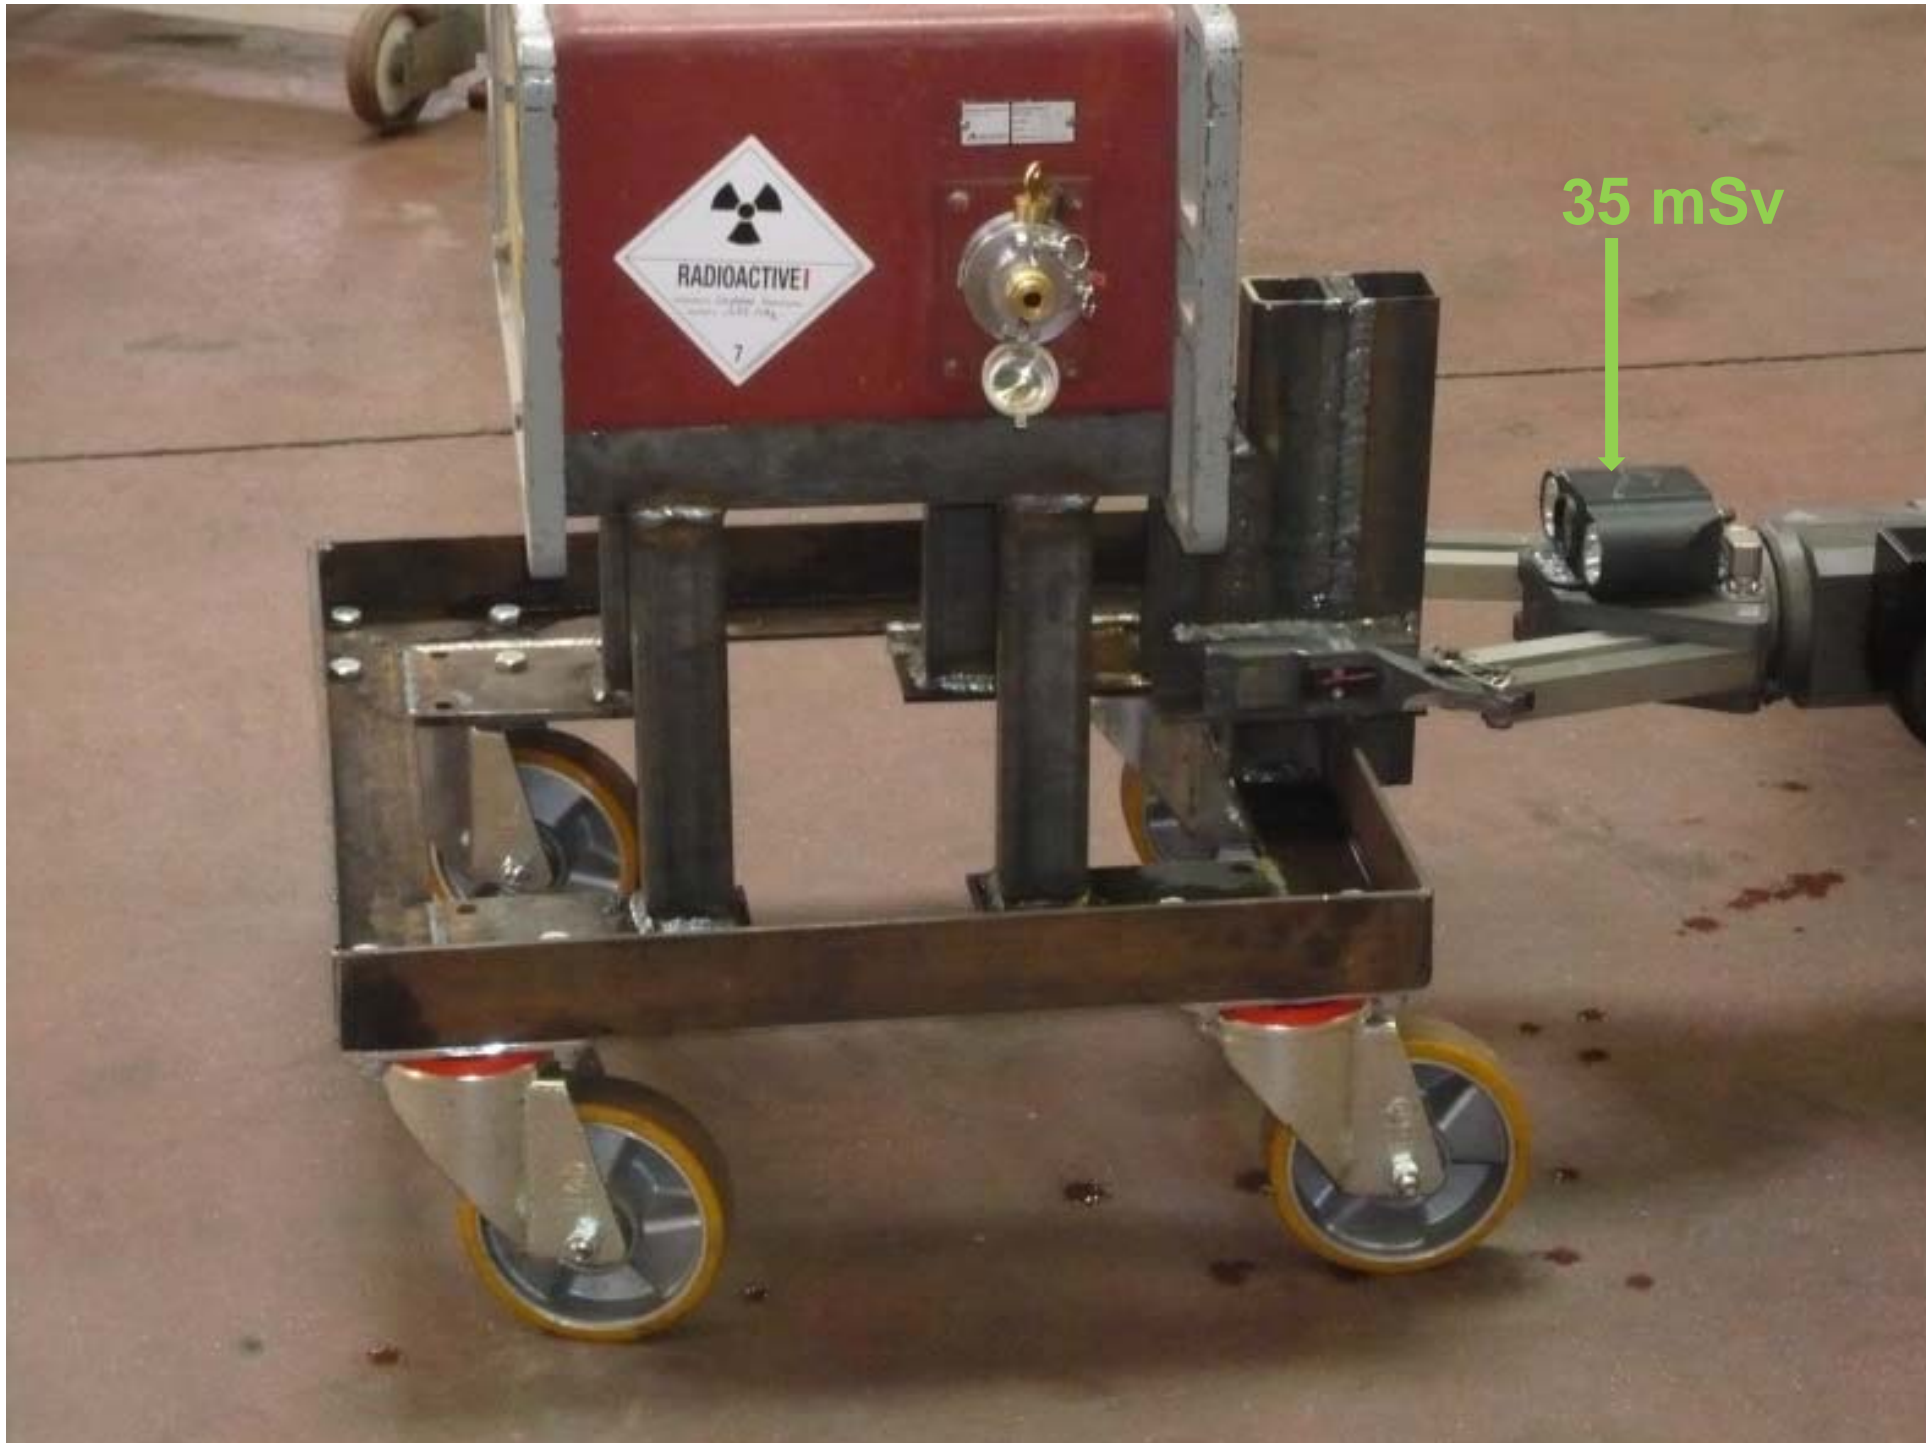
35 mSv

CAUSE:

**Preliminary risk assessment
&
human error**

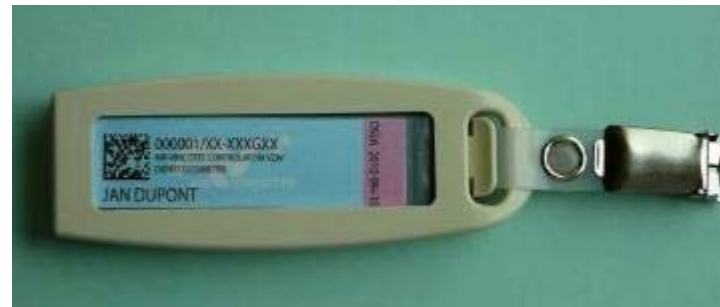
All intervenants present during the source retrieval wore an OSL dosimeter provided by AVC

All read-outs were below threshold.
